## **Structural Applications of Ferritic Stainless Steels (SAFFS)**

## **Beam fire tests report**

## Fire resistance tests of ferritic stainless steel beams

Test specimens were two ferritic stainless steel beams with RHS 40 x 80 x 2 sections (section factor  $F/V = 430$  1/m, and Grade 1.4509) the length of which was 1000 mm and the span 900 mm. One of the beams was uncoated and the other painted with primer Epigrip L425 (thickness 97.5  $\mu$ m) and intumescent paint Firetex FX13881 (thickness 1816  $\mu$ m / 1538  $\mu$ m). The tested beams loaded with total load of 9,96 kN distributed to two point loads met in the fire resistance test the performance criteria imposed by the standards *EN 13501-2:2007+A1:2009* complemented with *EN 1365-3:1999* and *EN 1363-1:1999* as follows:

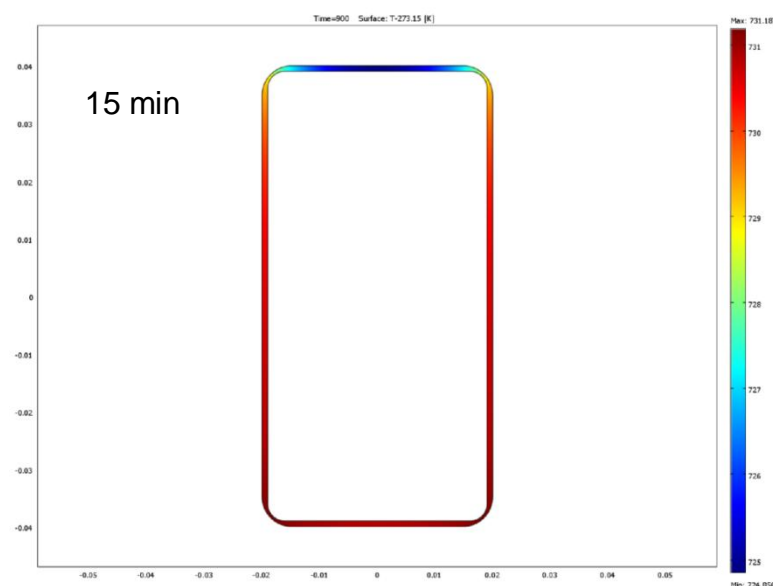
Geometry and temperature field of the uncoated beam is presented in Figure 1 at the time of 15 min. Temperature increase of the different edges of the beam in function of time is presented in Figure 2 until 30 min.

Figure 1. Geometry and temperature field of the uncoated beam.

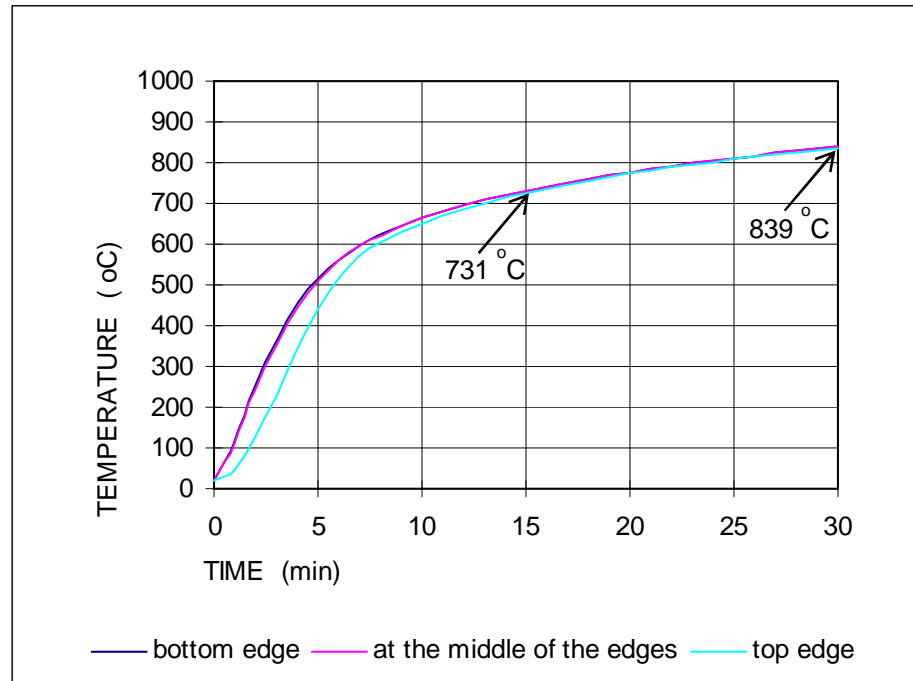
Figure 2. Temperature increase of the different edges of the beam.

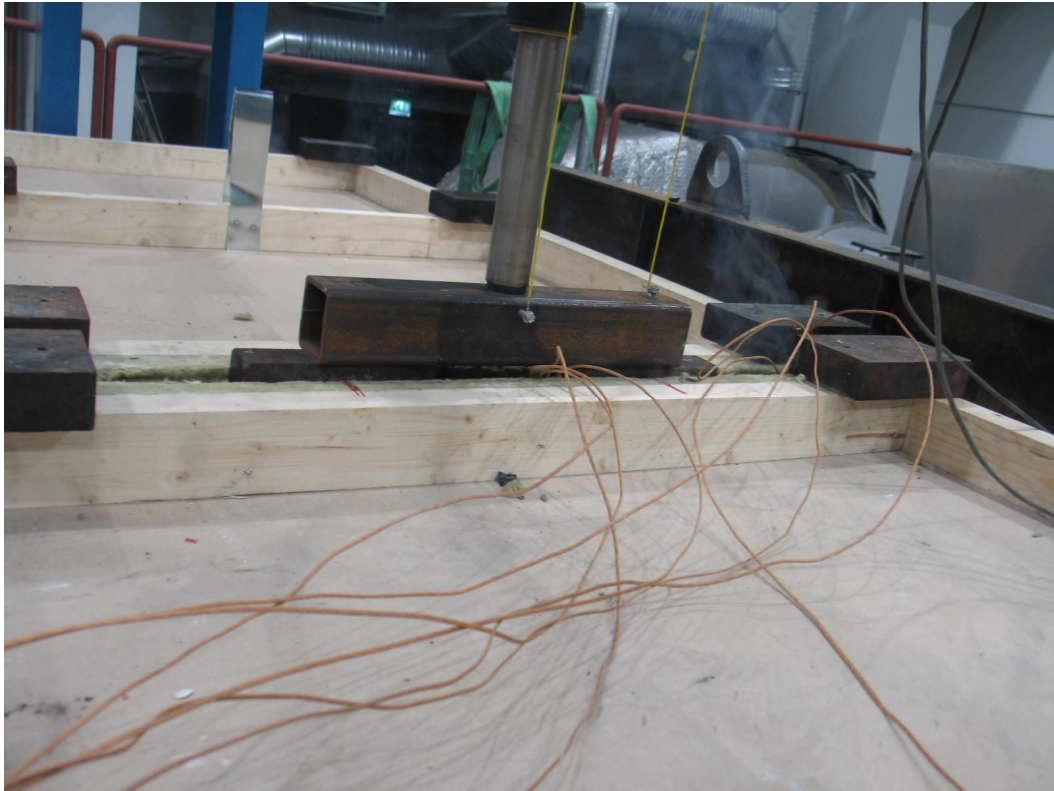
*Figure 5. Unexposed face of test specimen 1 at the test time 15 min 51 s.*

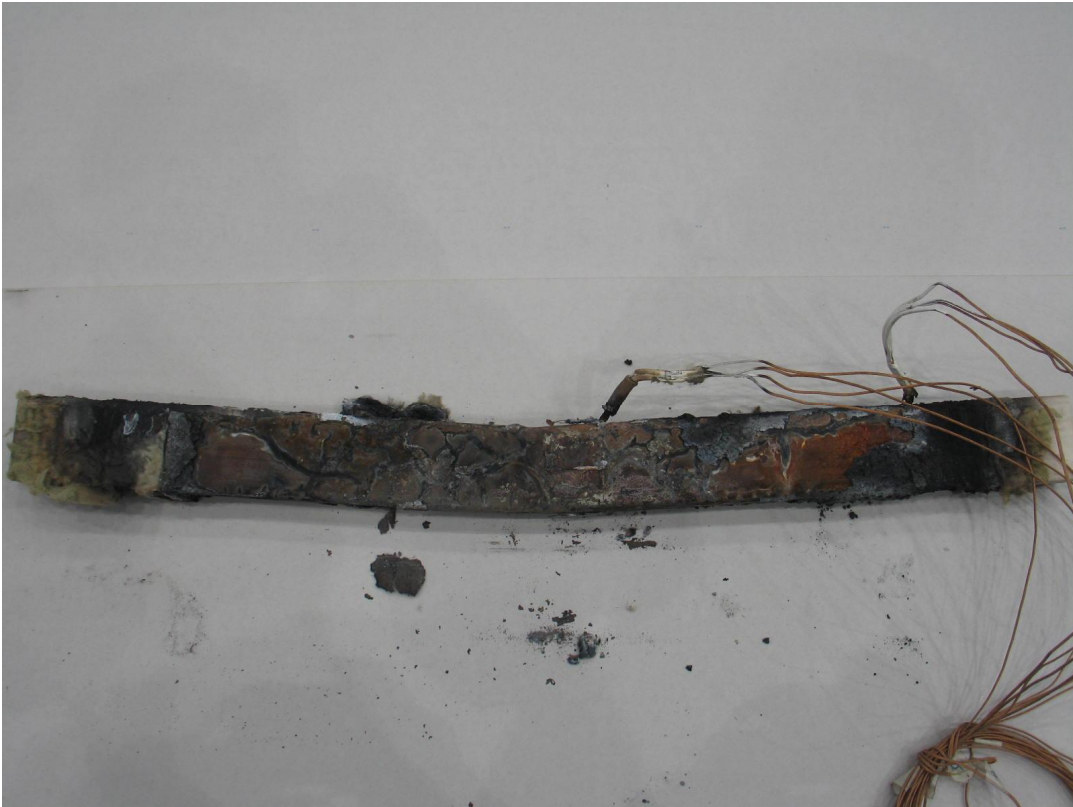
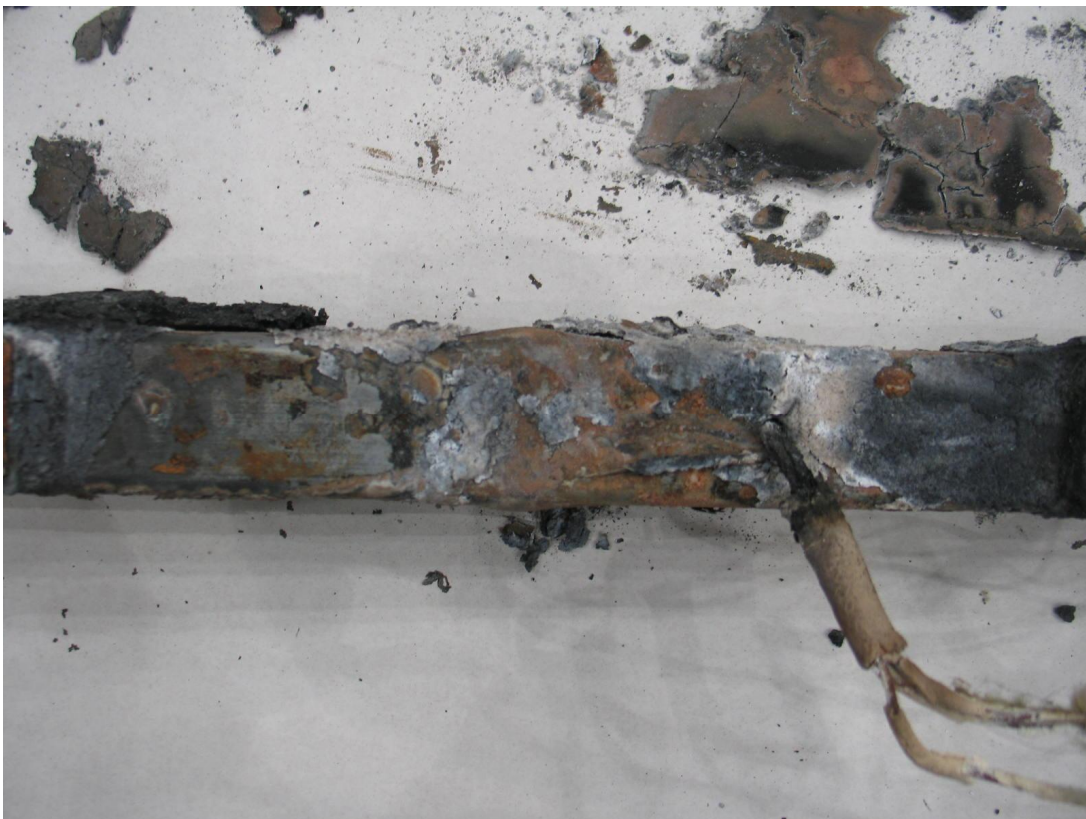
*Figure 10. Test specimen 2 after the test.*

*Figure 11. Test specimen 2 after the test.*

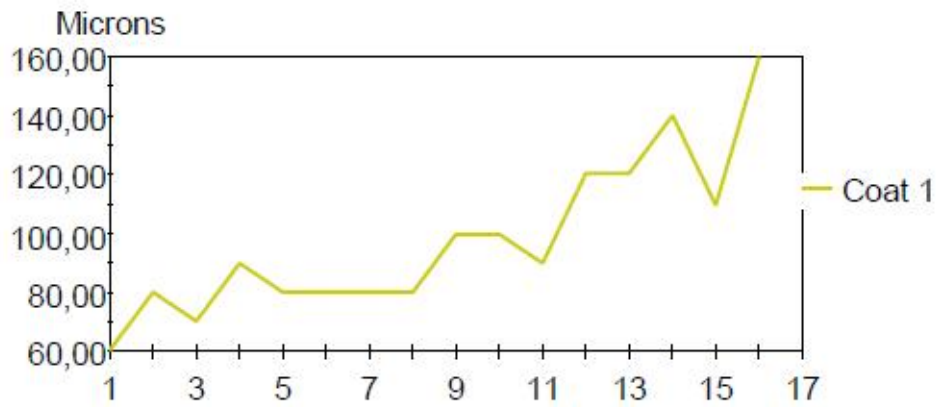
Figure 3 continued. Thickness measurements of primer Epigrip L425
