<b>Project name:</b>	Structural Applications of Ferritic Stainless Steels
Project's short name:	SAFSS
Project number:	39594

**Work package 2:**  
**Model calibration tests – Members in fire**

**Barbara Rossi**  
University of Liège

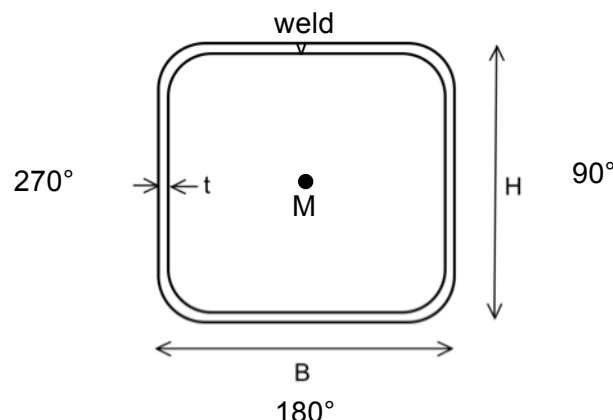
Figure 1. Notations for the cross-section dimensions

The cross-section areas were calculated on the basis of an average measured corner internal radius  $R_i$  of 4.0 mm for the 80 x 80 x 3 sections and 3.86 mm for the 120 x 80 x 3 section as follows

$$A = 2t_{av} \left[ B + H - 4(R_i + t_{av}) \right] + \pi(R_i + t_{av})^2 - \pi R_i^2$$

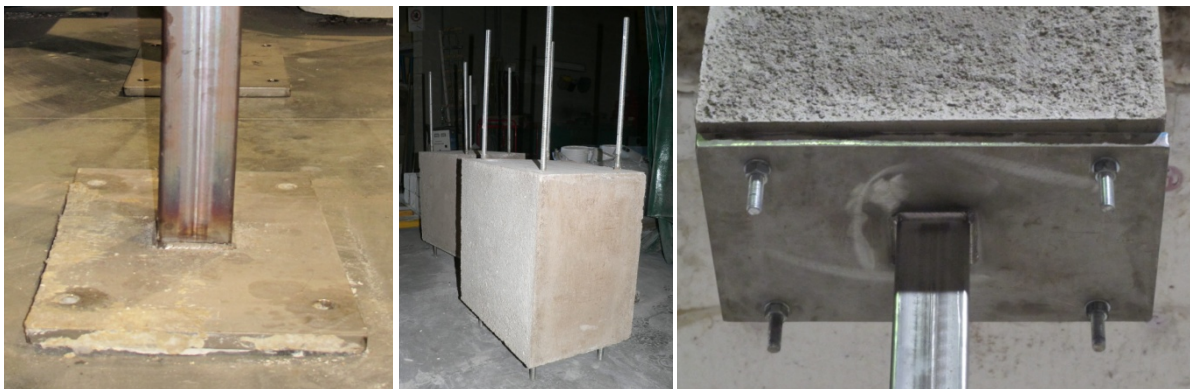
**Figure 2. Left to right – bottom end plate with holes for bolts, supporting concrete block with waiting steel bars, column top end with plate mounted on the concrete block**

The specimens were welded to 20 mm thick end plates (see Figure 2) made of stainless steel grade 1.4307 and holes for bolts were allowed for to ensure a full degree of fixity at both column ends. In fact, all tests were conceived with double fix-end conditions. The welding wire was made of 1.4430 stainless steel grade. The depth of the welded lips was 5.0 mm thick.

The plates bolted to the concrete blocks were covered with a fine grain temperature resistant plaster to guarantee an optimal contact with the plate (Figure 2). The interior volume of the furnace was then covered with ceramic fibre including the supports made of concrete. Therefore, the heated length reduced of approximately 50 mm (the fibre is 25 mm thick, Figure 5).

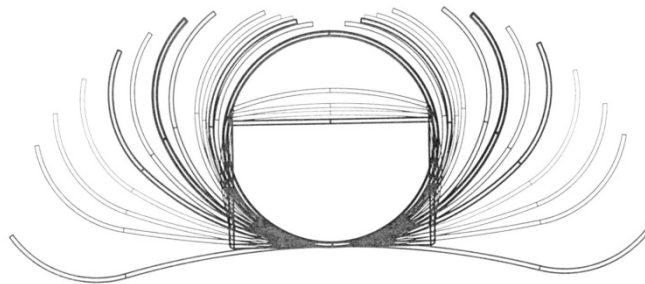
**Figure 3. Bending sequences occurring during the manufacture of a rectangular hollow section (credit: L. Faivre Aperam)**

Cold-formed structural sections are manufactured at ambient temperature and hence undergo plastic deformations, which result in an increase in yield stress and a reduction in ductility. Square and rectangular hollow sections are first formed into a circular section than further crushed into a square or a rectangular cross-section. Materials, such as stainless steel, with rounded stress-strain behaviour and significant strain hardening show a more pronounced response to cold working. Compared to the mill certificate data, the tensile coupon tests indicate that the flats experienced hardening especially the face situated in front of the weld (180° in Figure 1) because of the bending sequences. It is explicable by the fact that in addition to the bending curvature enhanced by the whole cross-section during fabrication into a circular hollow section, the inferior face is also bent in the opposite direction (see the bending sequence development depicted in Figure 3). This may also significantly harden the base material and lead to a higher strength and lower ductility (Rossi et al., 2013).

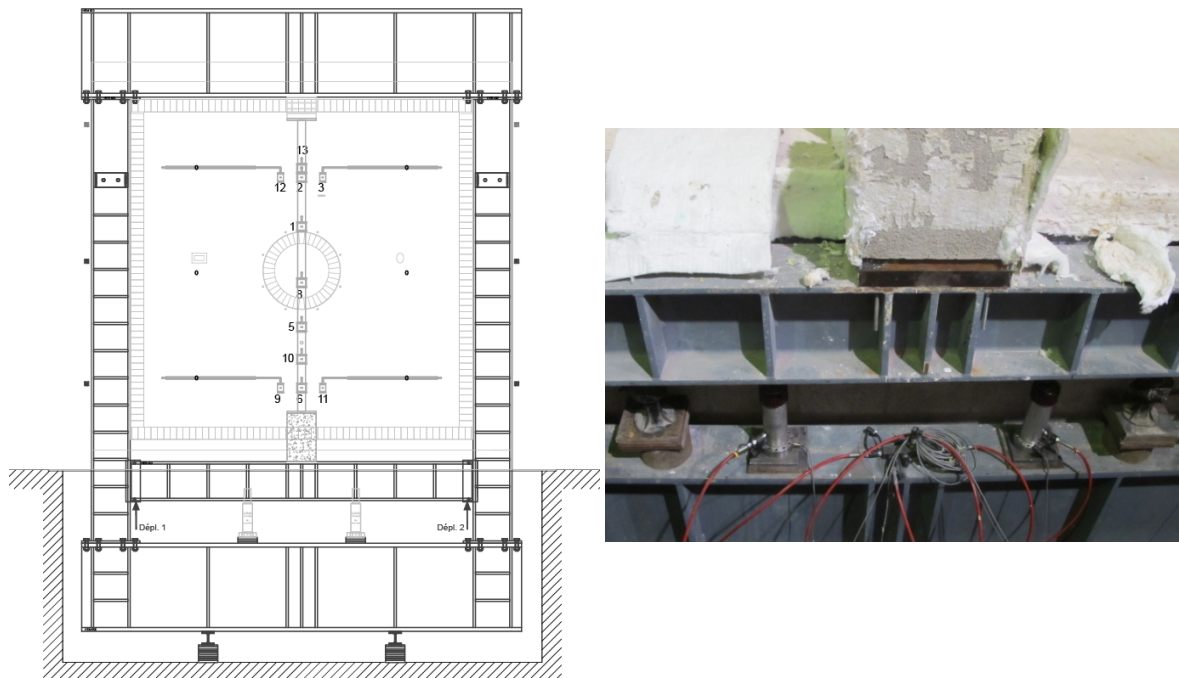
**Figure 4. Left to right – schematic elevation of the vertical furnace, lower beam with left and right jacks**

The columns were tested in the vertical wall furnace at the Fire Testing Laboratory of the University of Liege, the competence of which is certified by the accreditation to the ISO 17025 standard delivered by the Belgian accreditation body BELAC. The furnace is provided with a system capable to impose vertical loads to the specimens. The bottom horizontal beam (HEB 400) can move up along slide guides attached to the columns of the reaction frame (Figure 4). These guides basically allow only the translational displacement (up and down). Slight rotation about the horizontal transverse axis of the beam may however occur owing to connection slacks. In fact, for the three tests, a small adjustment was observed at the beginning of the static loading then both displacement transducers (left and right) provided the same measure indicating that the lower support did not rotate. The load was transmitted to the column through the lower beam connected by means of two jacks, as depicted in Figure 4.

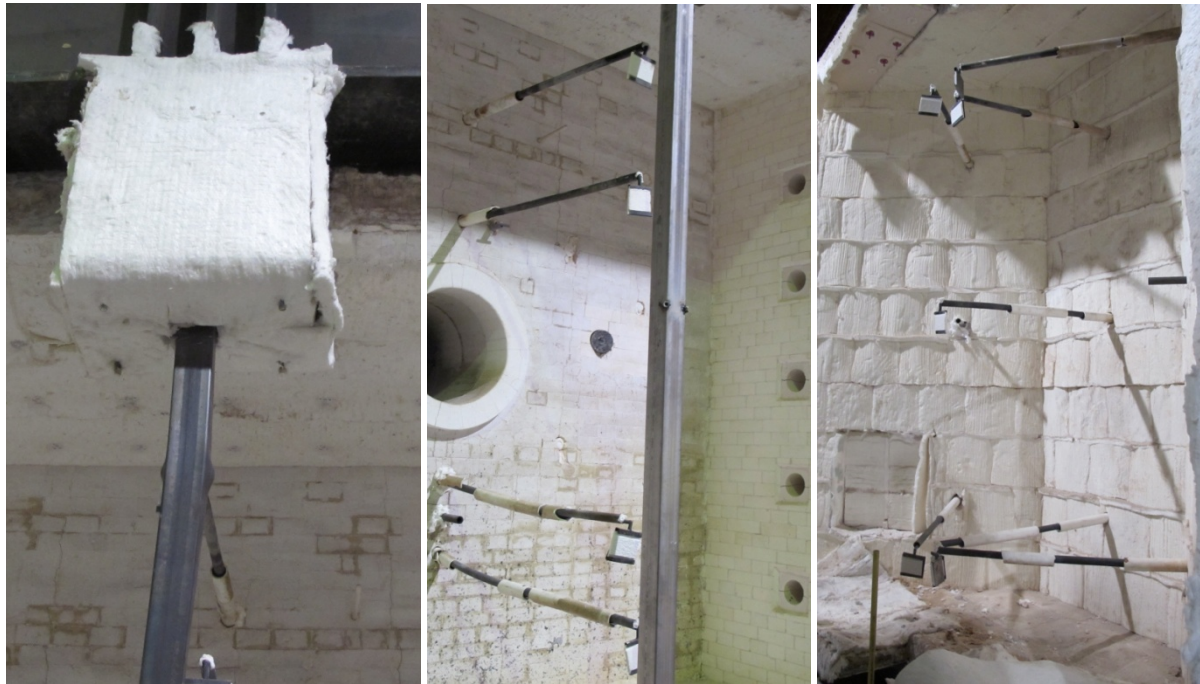
**Figure 5. Left to right – column top end covered with ceramic fibre, 4 pyrometers located at the back side of the column, 7 pyrometers located at the front side of the column through the furnace closing device**

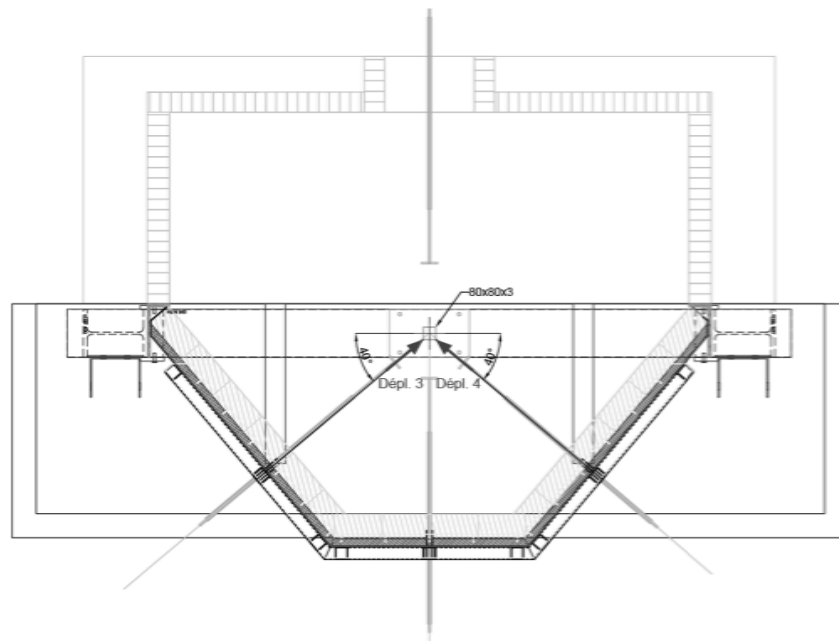
**Figure 6. Schematic plan of the vertical furnace (seen from above), indicating where and how the transverse displacements (*dépl. 3* and *dépl. 4*) are measured**

Presently, we measured the transverse displacements by replacing two (out of 11) pyrometers with two ceramic stalks (located at 1429 mm from the bottom end of column #1 and at 1319 mm from the bottom of columns #2 and #3) and oriented at forty degrees from the column faces, see Figure 7. The displacement transducers (located outside the furnace)

measured the movements of the stalks that were connected to the column by means of two bolts (*dépl. 3* and *dépl. 4*, see Figure 6 and Figure 7). Those two measures are relevant only at the beginning of the loading when they remain sufficiently low, i.e. when the measure along the stalk equals the transversal component.

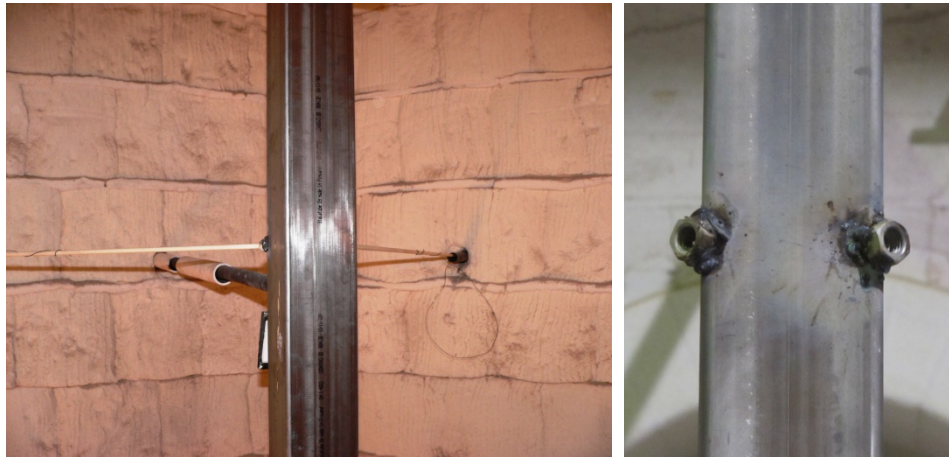
Figure 7. Left to right: displacement transducers placed to measure transverse displacement; a detail of bolts used to support them

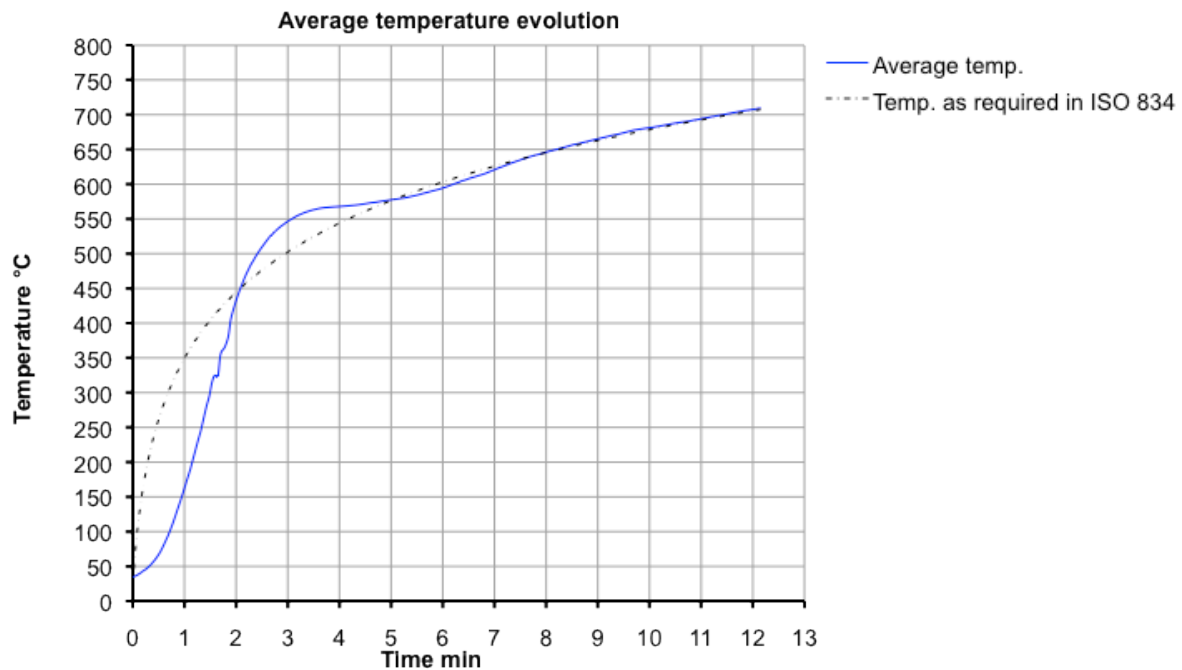
Figure 8. Average air temperature evolution for column #1

The time of failure occurred at 12 min 9 s after *time zero* and at the air temperature of 709.4 °C.

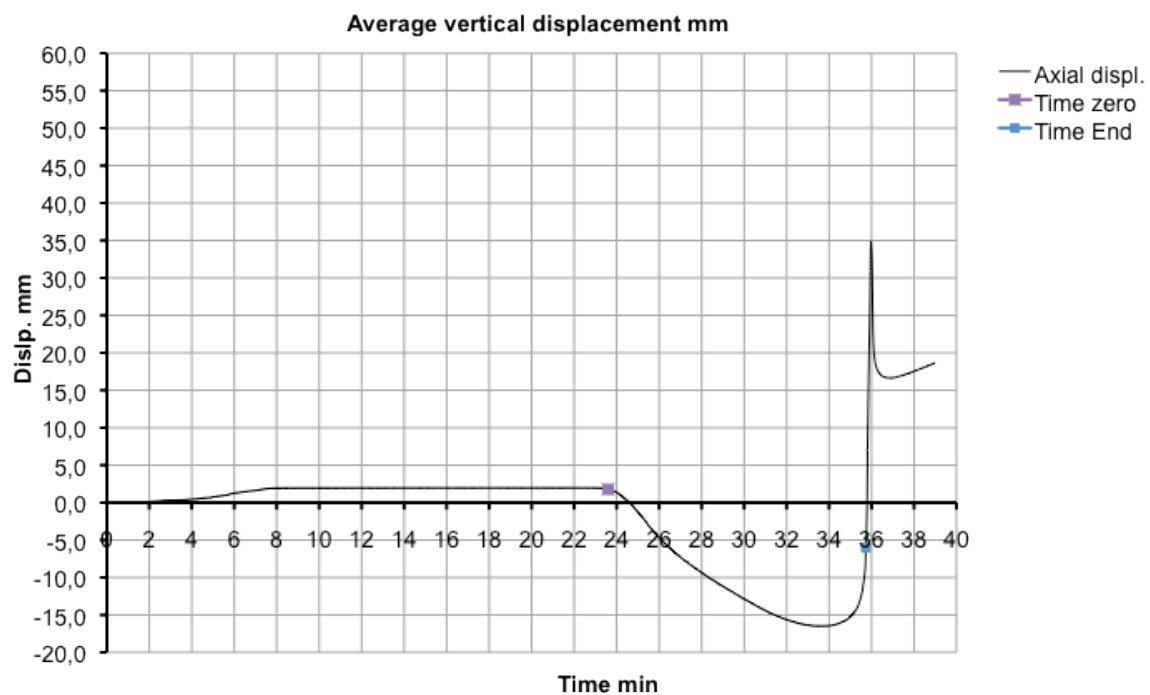
From Figure 9 it is possible to observe that the axial displacement was first positive owing to elastic shortening of the column at ambient temperature. Then, when the fire test began it became negative because of thermal expansion.

Figure 9. Average axial displacement versus time for column #1

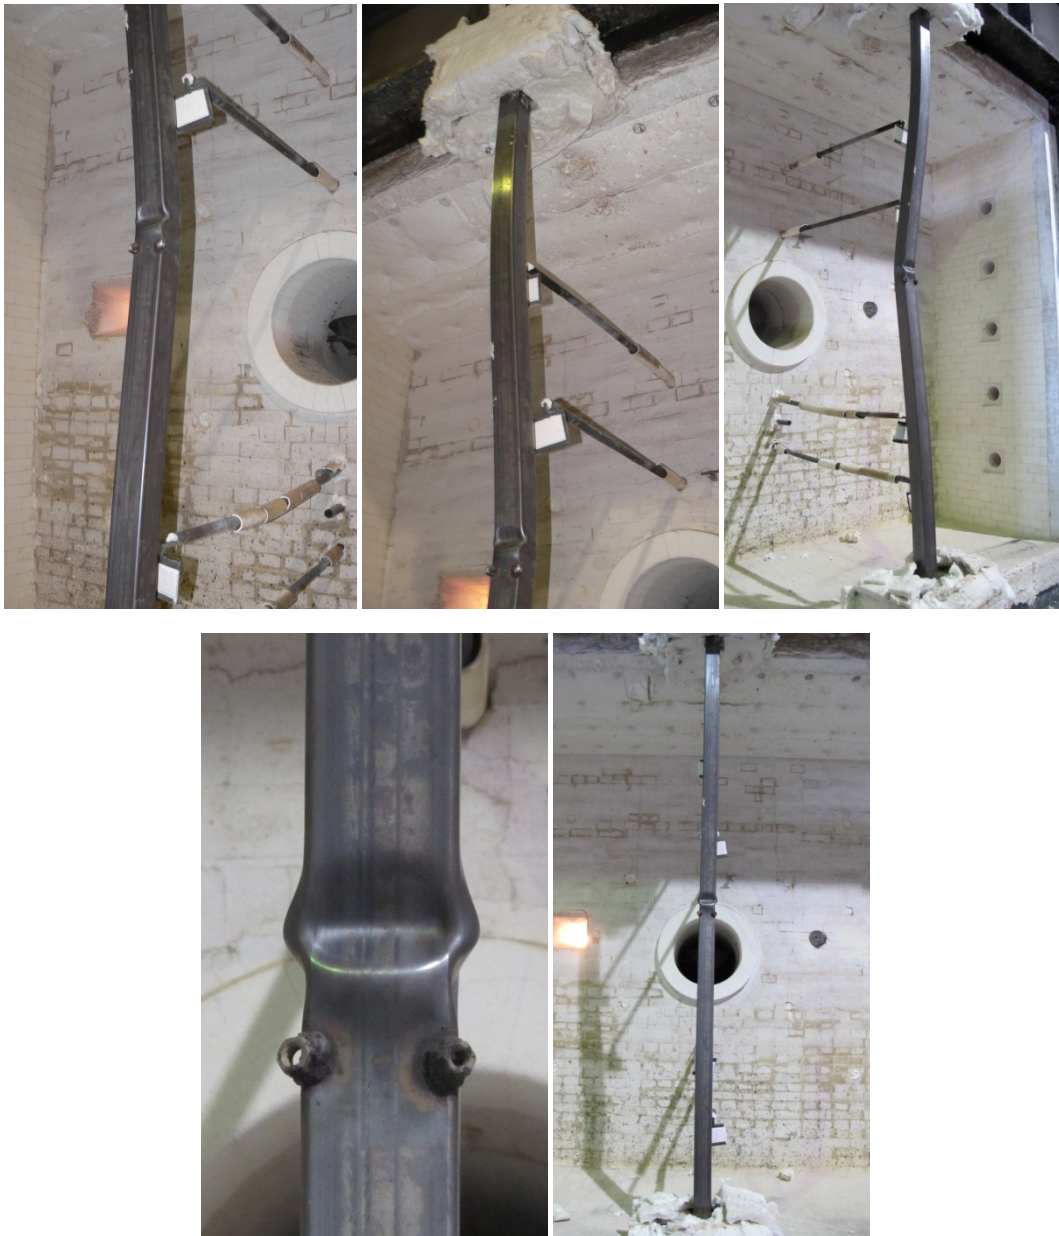
Figure 10 shows column #1 after being tested. The failure mode involved the formation of a main plastic hinge at the column centre and, less developed, at about a quarter and at two quarters of the height. Thus, full *fixed-end* boundary conditions seemed to be achieved.

Figure 10. Failure mode for specimen #1 (3 m long)

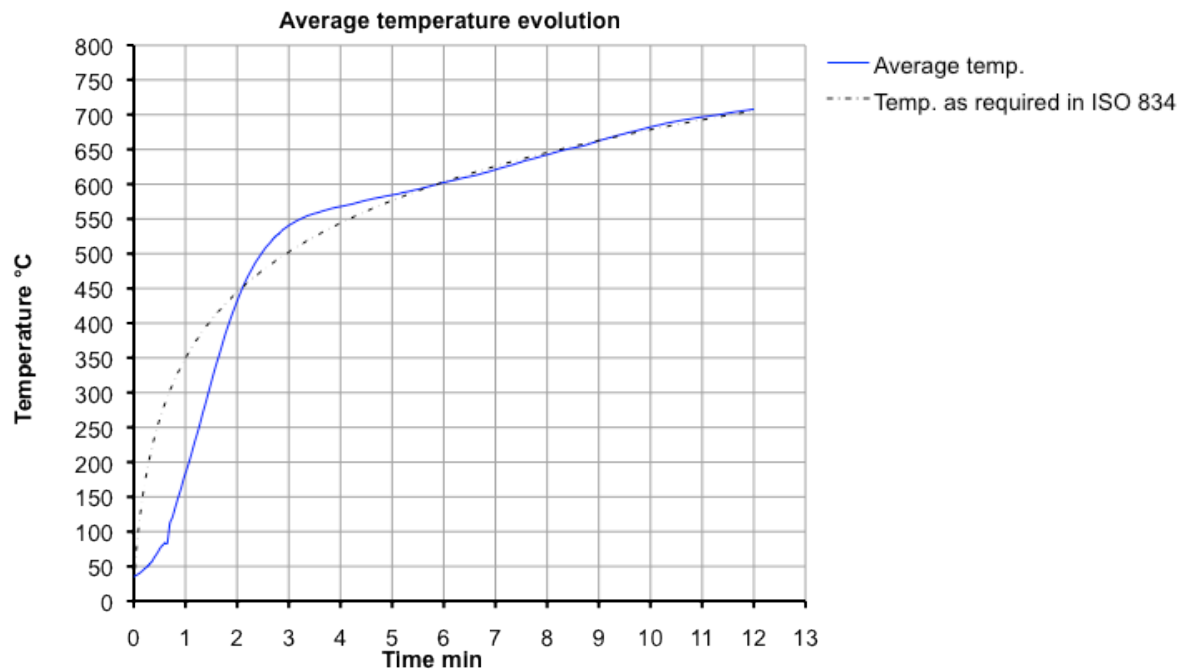
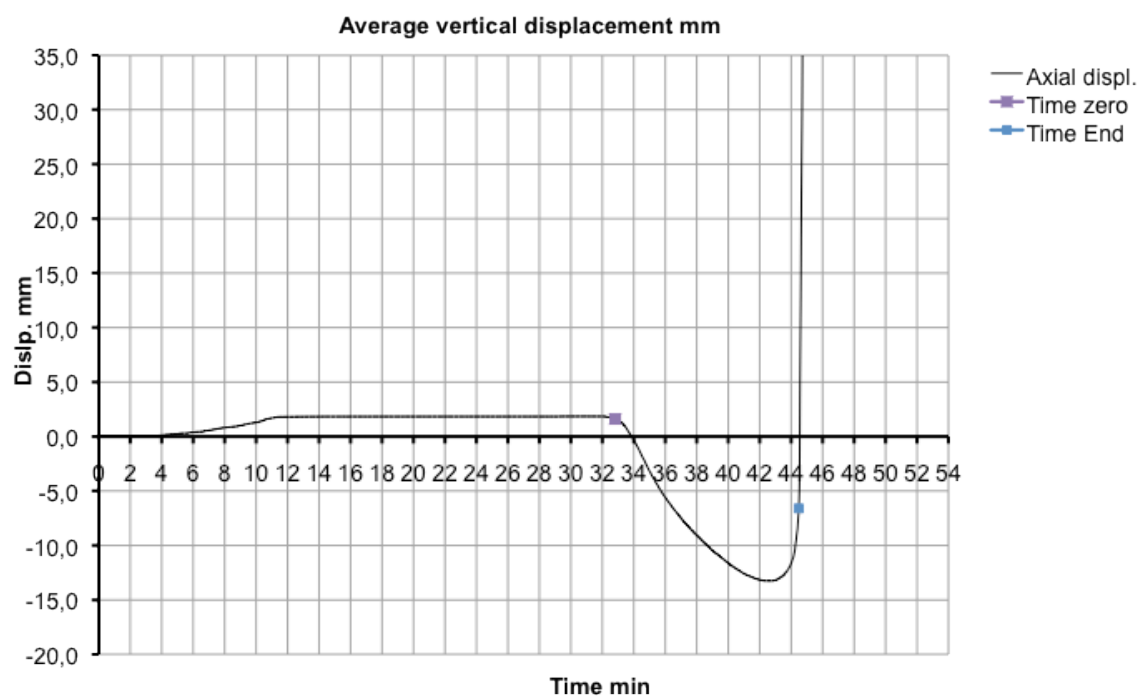
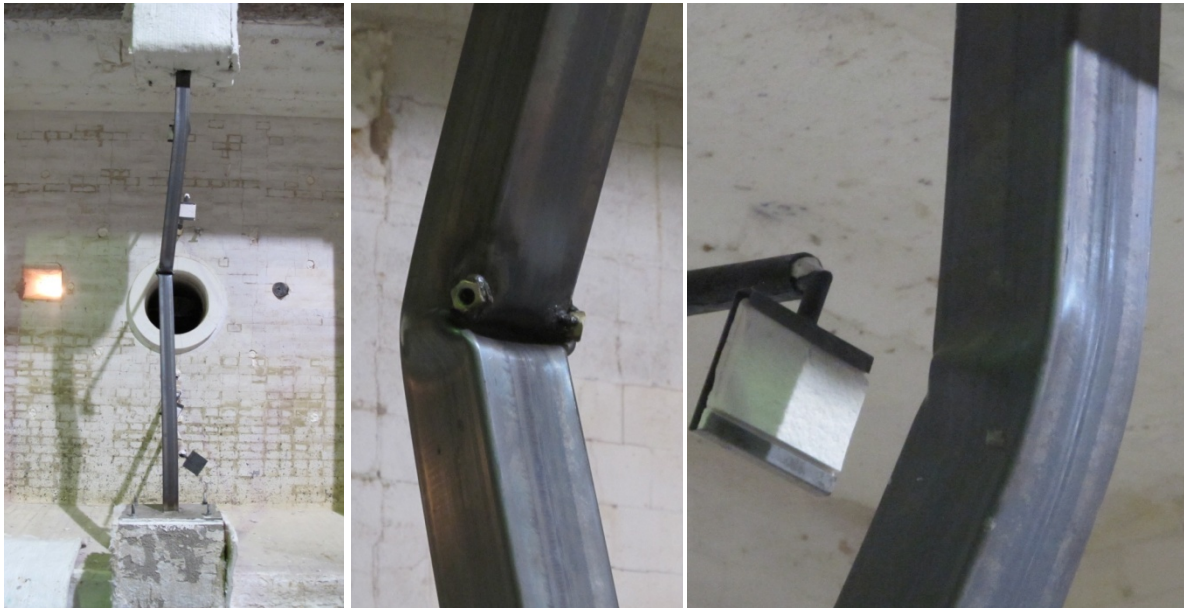
Similar considerations as those made for column #1 can be drawn for column #2 too, as presented in Figure 11 to Figure 13. However, in this test the plastic hinge at the top of the column was more developed than in the previous test. The time of failure occurred at 12 min after *time zero* and at air temperature of 707.7 °C.

Figure 11. Average air temperature evolution for column #2

Figure 12. Average vertical displacement versus time for column #2

Figure 13. Failure mode for the column #2

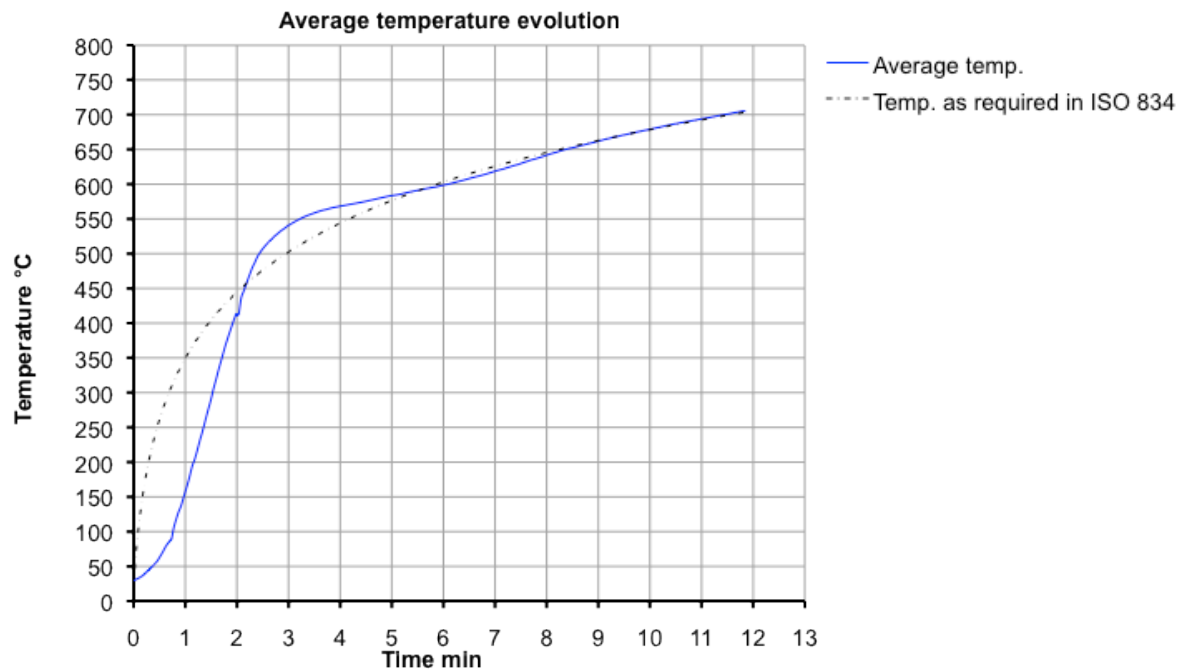
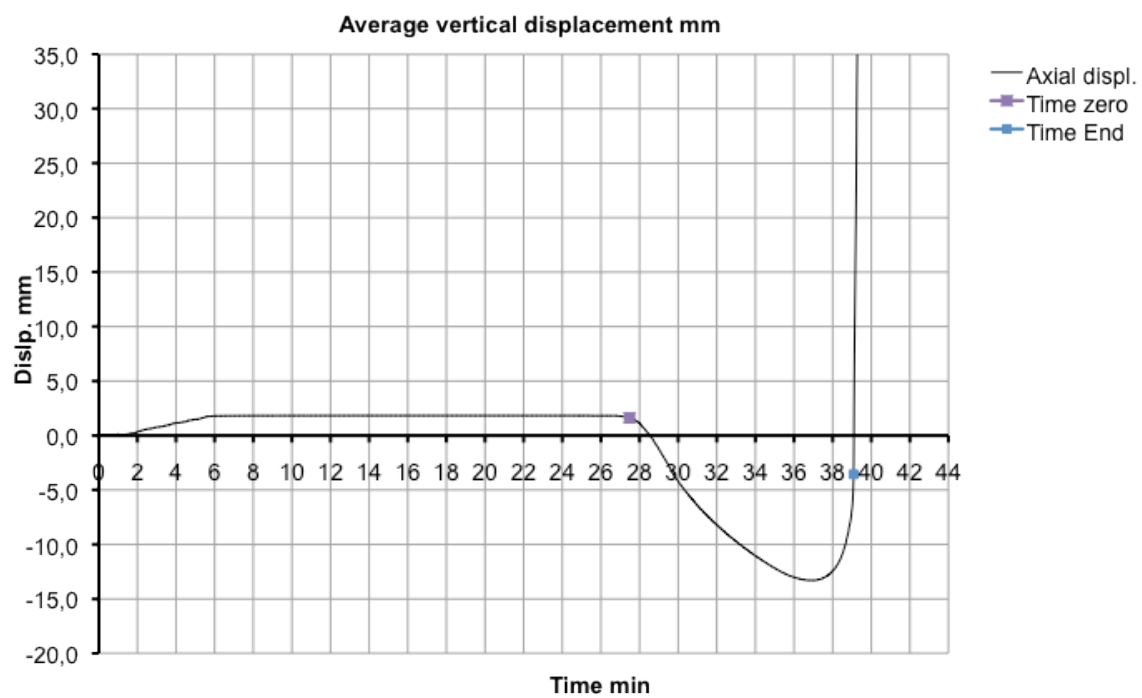
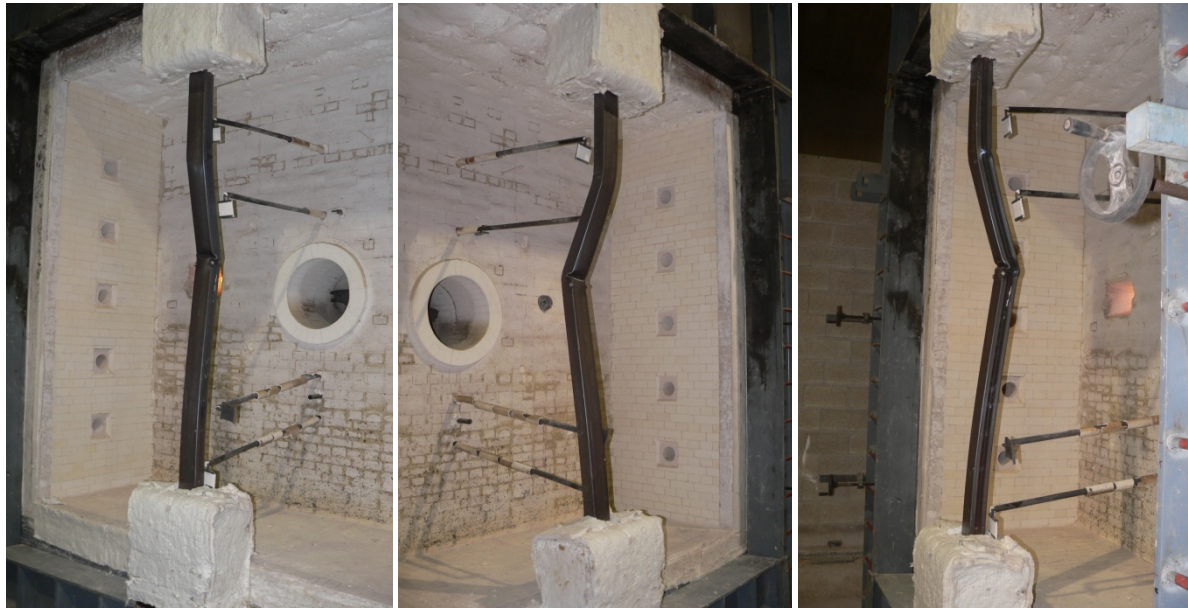
For column #3 the time of failure occurred at 11 min 51 s after *time zero* and at the air temperature of 705 °C. Thus, in terms of fire resistance it exhibited a similar behaviour as the one experienced by column #1 and #2. As expected, it failed around its weak axis. The mode of failure was characterised by the formation of two clear plastic hinges (approximately at the top and at midspan), as shown in Figure 16. The explanation of such a behaviour is described Section 2.5.

The analysis of the transverse displacements by supposing no torsion confirmed the experimental observations. For specimen #3 bending clearly occurred about the weak axis. First, the column had a slight movement involving a major axis flexural displacement, which was quickly followed by the main movement about the weak axis.

Figure 14. Average air temperature evolution for column #3

Figure 15. Average axial displacement versus time for column #3

Figure 16. Failure mode for column #3

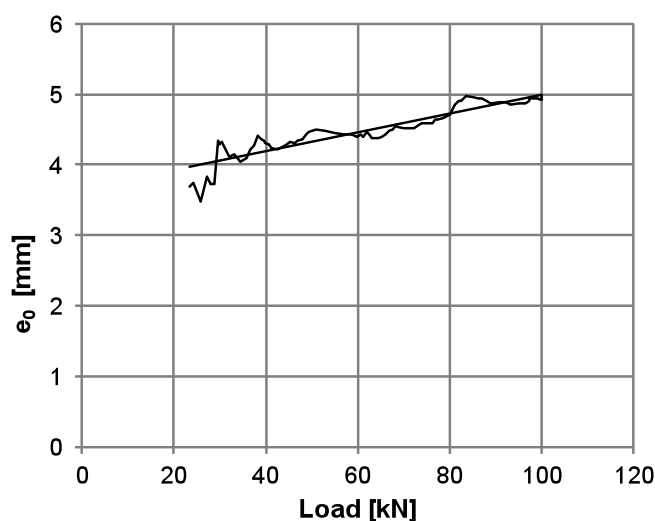
**Figure 17. Initial imperfection calculated using Southwell diagram for the specimen #3**

From the beginning of this experimental campaign, efforts were made to achieve a *fixed-end* boundary conditions (no lateral displacements nor rotation and warping). Theoretically, in full-restrained conditions, failure would occur with an almost simultaneous formation of three plastic hinges located at the top section, at the mid-height section and at the bottom section of the column. However, in the tests it was observed the formation of two plastic hinges - at the top section and at the mid-height section - rather than three. Firstly, it was supposed that full-restrained conditions were not achieved, above all at the base section where in every tests no clear plastic hinge formed. As a partial confirmation of this hypothesis, for column #3 the initial imperfection  $e_0$  was estimated according to the Southwell diagram (Southwell, 1932) by relying on experimental data and by assuming an elastic critical load of a condition fixed-simply supported. Figure 17 shows that  $e_0$  is rather constant and comprised between 4.0 and 5.0 mm, a range of values that can be well correlated to the measured imperfection for specimen #3. However, this finding was only valid for column #3.

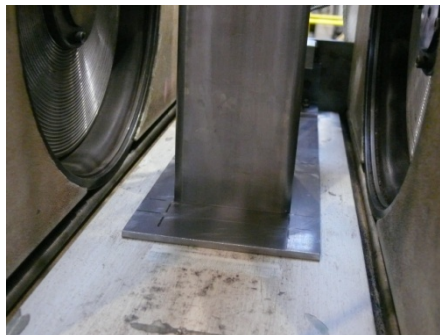
**Figure 19. End plates allowing full-restrained boundary conditions**

The machined ends of the columns allowed for a perfect contact with the loading device. Full-restrained boundary condition was achieved during the tests (Figure 19). The column was concentrically loaded using a Schenk hydropolus whose maximum capacity is 2500 kN. The loading was displacement-controlled with speed 0.5 mm/min. Both axial and transversal displacements were measured. The global flexural transversal displacements in two perpendicular directions were measured using extensometer placed at the centre of the column (Figure 20).

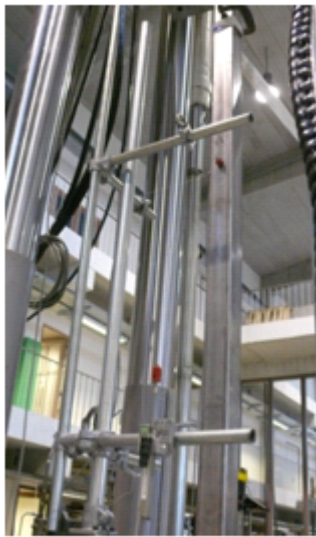
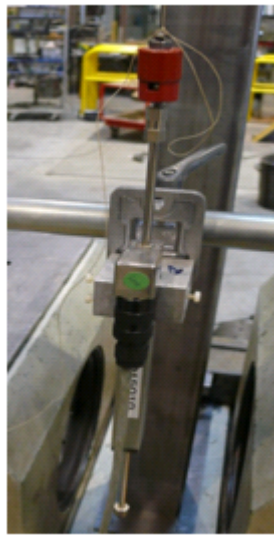
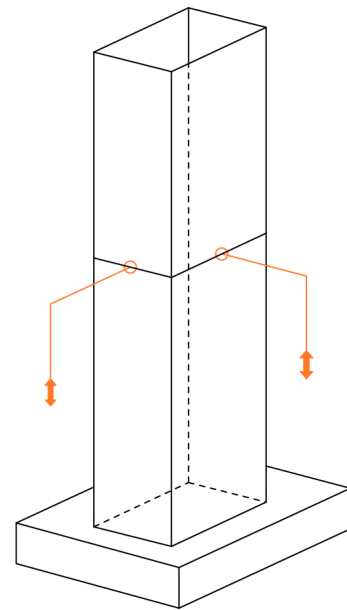
**Figure 20. Vertical system of pulleys for the measurement of the transverse displacements and corresponding transducers**

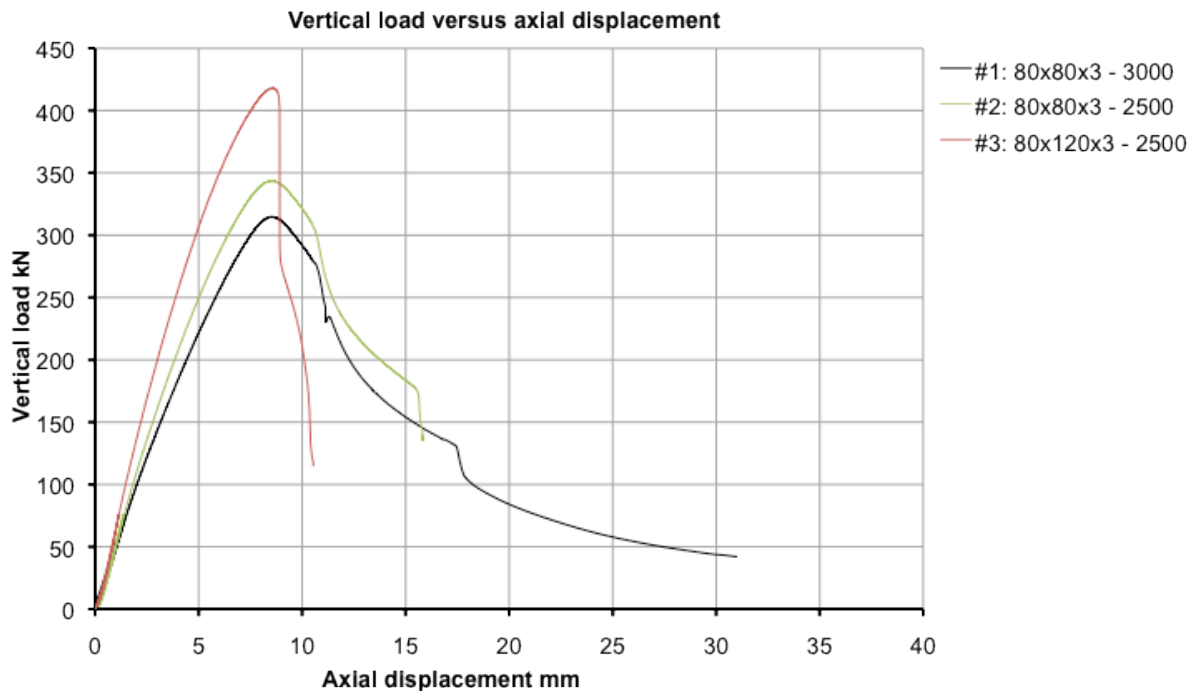
Figure 21 depicts the global behaviour of the columns in terms of axial load versus axial displacement. These tests showed that the axial capacities were higher than predicted, primarily owing to a higher average yield strength, Table 3 and Table 7).

**Figure 21. Average axial displacement versus load for the specimens #1 to #3**

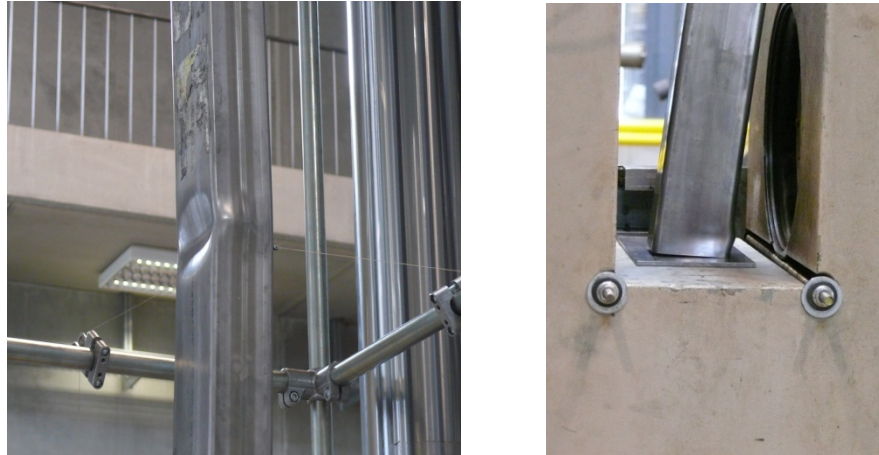
All the three columns failed in the same way, by combination of local buckling and global flexural buckling. During the tests it was possible to observe local buckling waves; however their amplitude was not measured. Elastic buckling firstly occurred. Then, plastic hinging appeared at midspan and at both column ends associated with increasing transverse

displacement and failure eventually occurred owing to global buckling (Figure 22). Both column ends experienced a small detached zone as well (Figure 22).

**Figure 22. Post-buckling behaviour Left: Plastic mechanism in the middle of the column. Right: Plastic mechanism at the bottom end.**

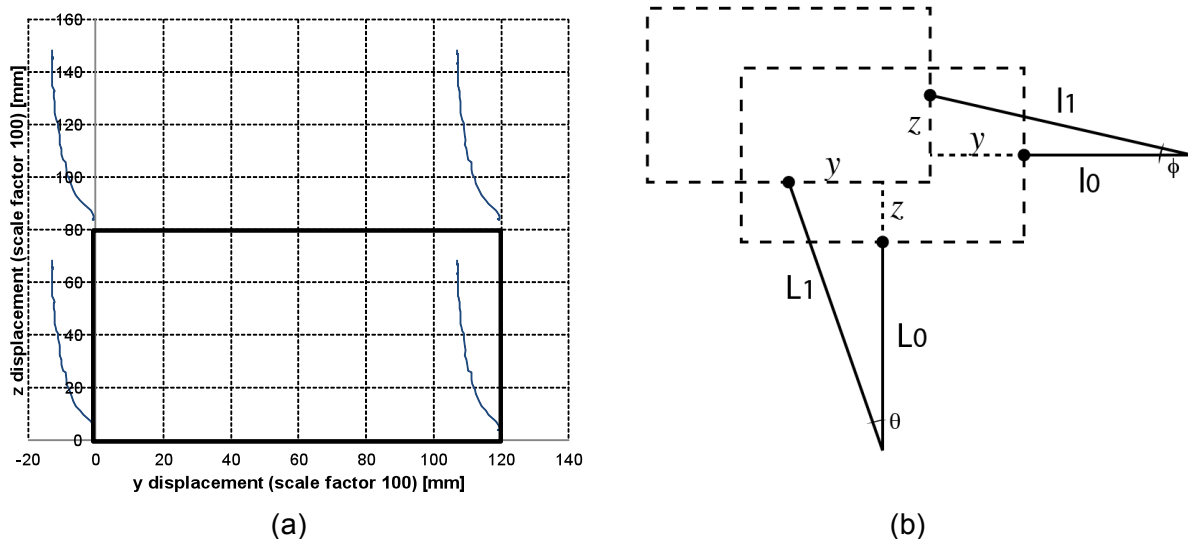
For the specimen #3 (RHS), bending occurred about the weak axis, as illustrated in Figure 23a. The assumption of no torsion was taken into account in order to compute the transverse displacements, see Figure 23b. For the SHS (columns #1 and #2), a combined flexural buckling about the two axes was detected.

**Figure 23. a) Evolution of transverse displacements of column #3 (displacements increased by a factor of 100); b) scheme showing the assumptions to calculate transverse displacements, L1 and L0 are the measured displacements which permit the evaluation of the local coordinates**

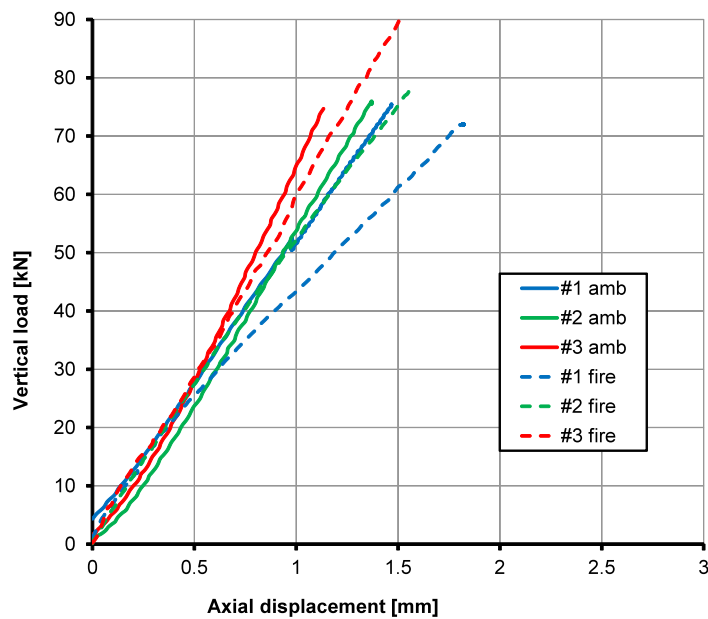
The comparison of the force-axial displacement curves between tests at elevated temperature and tests at ambient temperature (Figure 24) clearly showed different axial stiffnesses even though their ratios should be very close to 1.0. One reason lies in the fact that the columns tested at ambient temperature were shorter, as previously described, and that the set-up at the laboratory was more flexible, owing to a much more elaborated set-up with higher deformability.

Figure 24. Comparison of vertical load-axial displacement at the beginning of loading between tests at ambient and at elevated temperature.

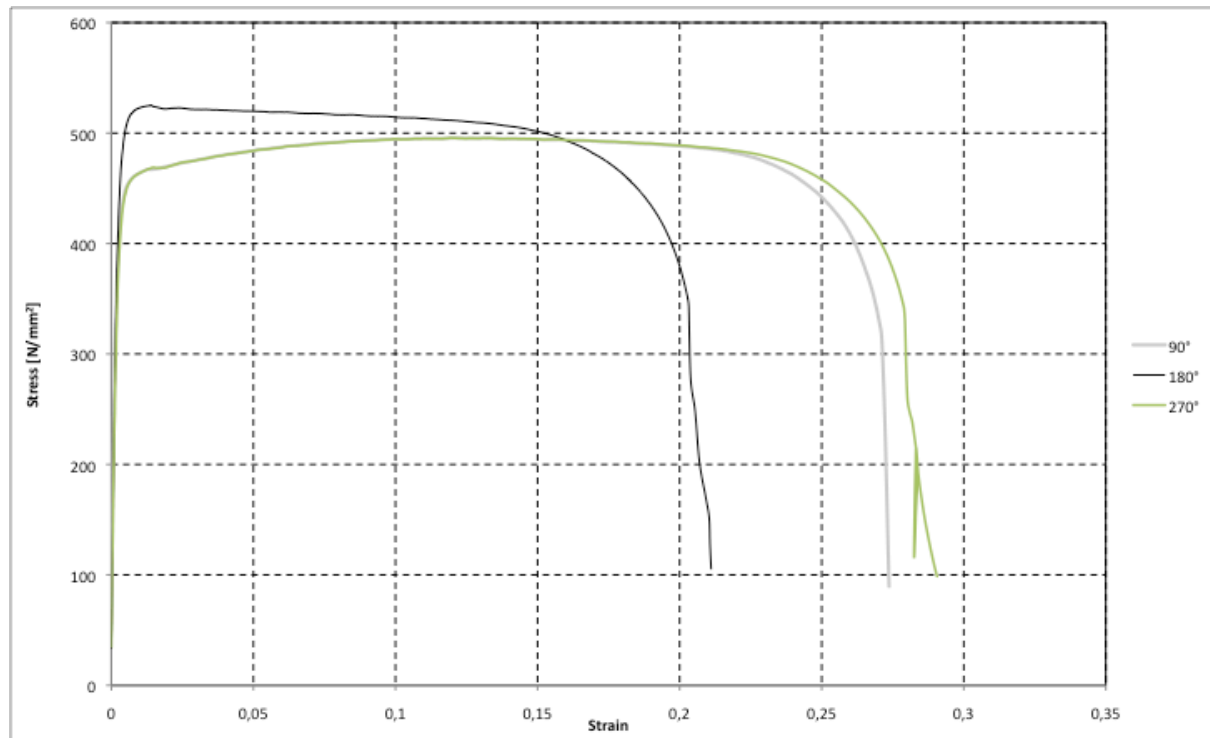
A2-1, Square Hollow section – Tensile coupon test results

Figure 1. The face that included welding was excluded. Coupons were cut out of the flat sides of the tubes and tested in an Instron 5582 electromechanical testing machine. Up to 1% elongation the test was carried out in load control with stress rate of 20 MPa/s. Then, it continued in displacement control at strain rate of 40% $L_0$ /min; where  $L_0$  is the initial specimen length. Young's modulus was computed in the loading phase between 0.03% and 0.07% elongation. The mill certificate data and average tensile coupon tests properties are provided in Table 2 and Table 3. The full stress-strain curves are given in Appendix 2.

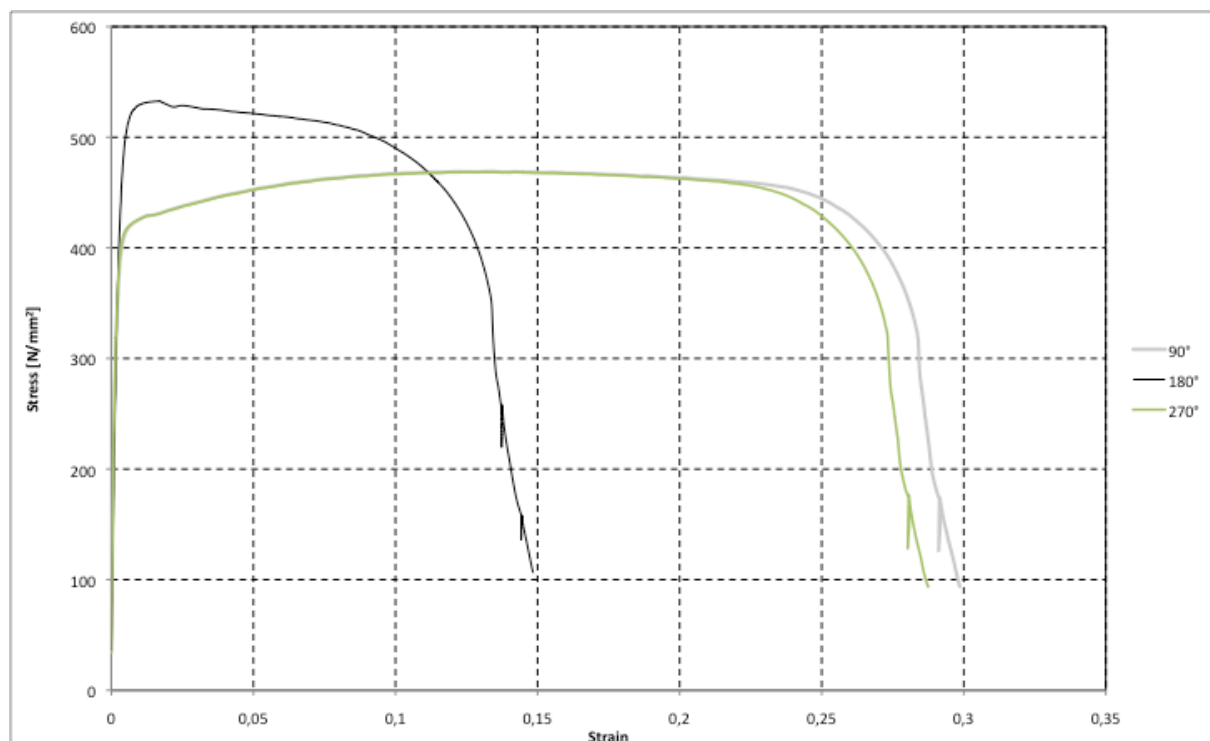
A2-2, Rectangular Hollow section – Tensile coupon test results

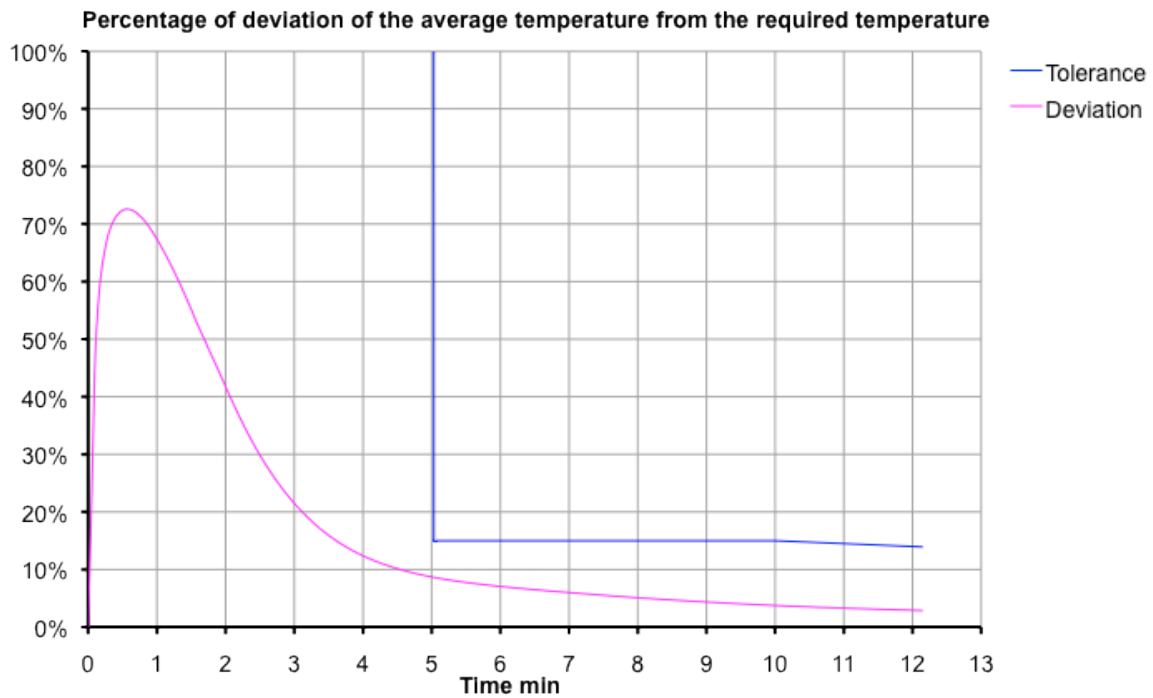
**A3-1. Average temperature deviation (from the required temperature) for specimen #1**

After the static loading at ambient temperature was applied, the fire test began according to the ISO 834 fire curve. It is worth pointing out that *time zero* conventionally means the time at which the temperature inside the furnace reaches 50°C. The temperature curve is defined using 16 points. A small deviation from the required curve is always observed at the beginning of the test because the change of temperature of the ISO curve is too fast to be followed by burners, see Figure 8. In fact, no tolerances are provided in EN1363-1 for the first 5 min. The deviation occurred in the test was measured and it respected the given tolerances (see Appendix 3 for column #1).

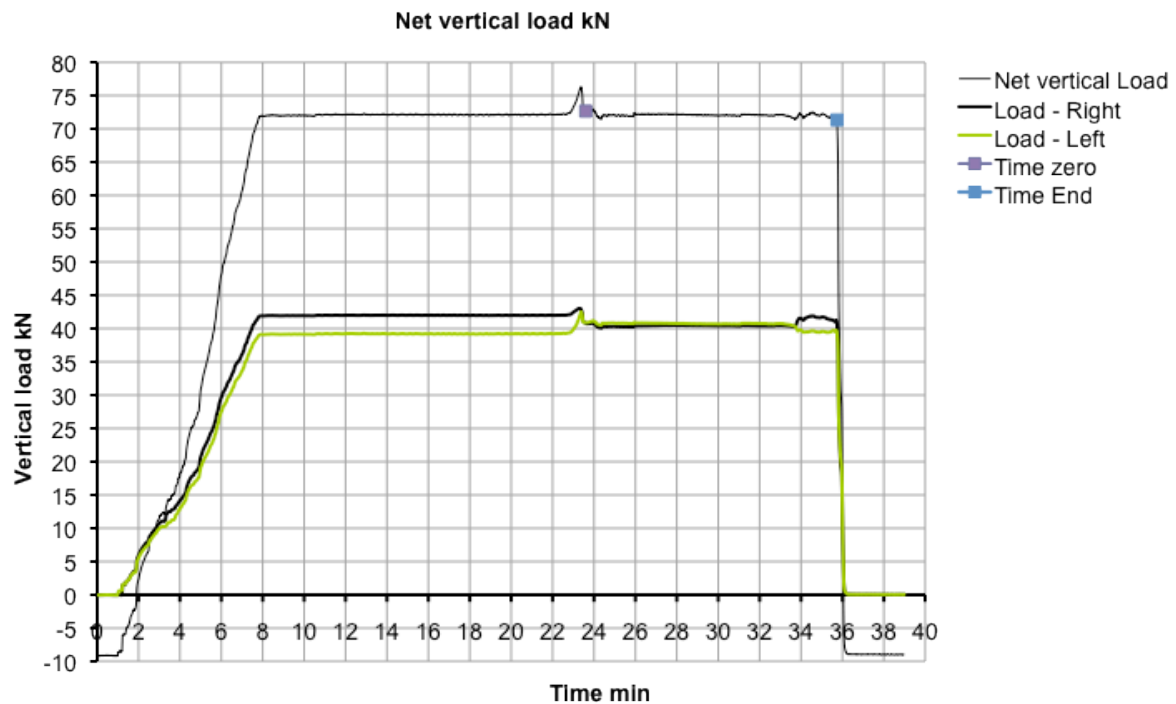
A4-1. Net vertical loads (left, right and sum minus tare) versus time for specimen #1; Time zero and Time End also indicates when the fire test occurs

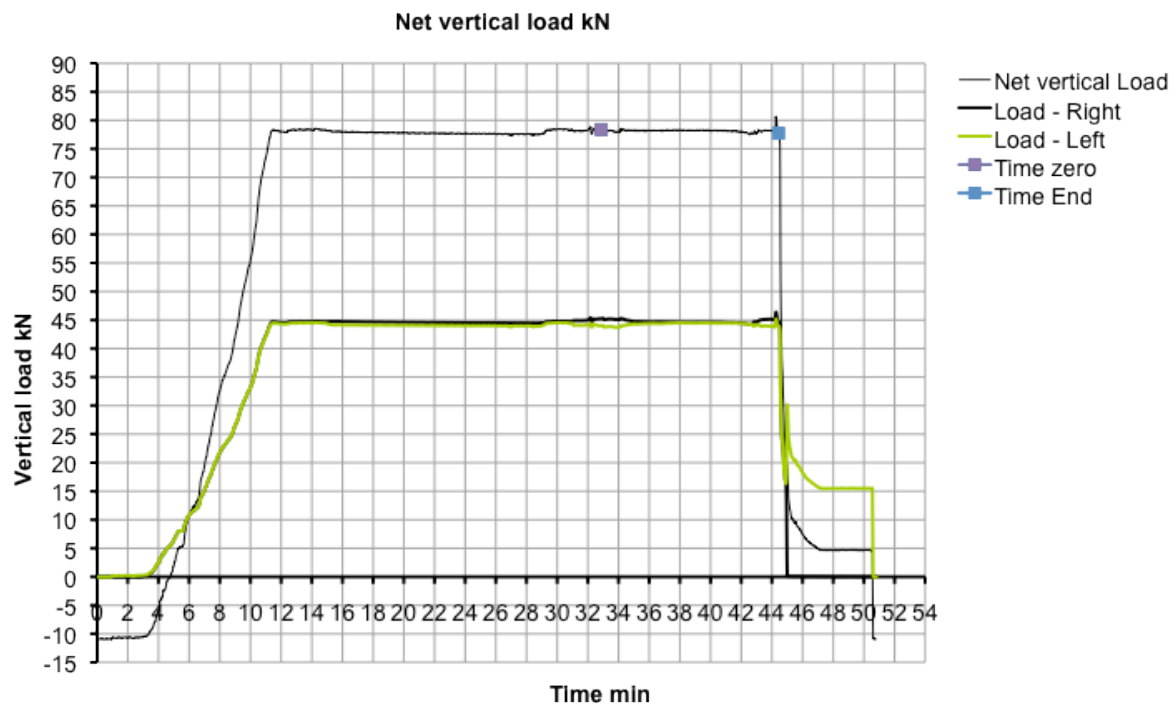
A4-2. Net vertical loads (left, right and sum minus tare) versus time for the specimen #2; Time zero and Time End also indicates when the fire test occurs.
