<b>Project name:</b>	Structural Applications of Ferritic Stainless Steels
Project's short name:	SAFSS
Project number:	39594

**Work package 2:**  
**Model calibration tests – Members in fire**

**Barbara Rossi**  
University of Liège

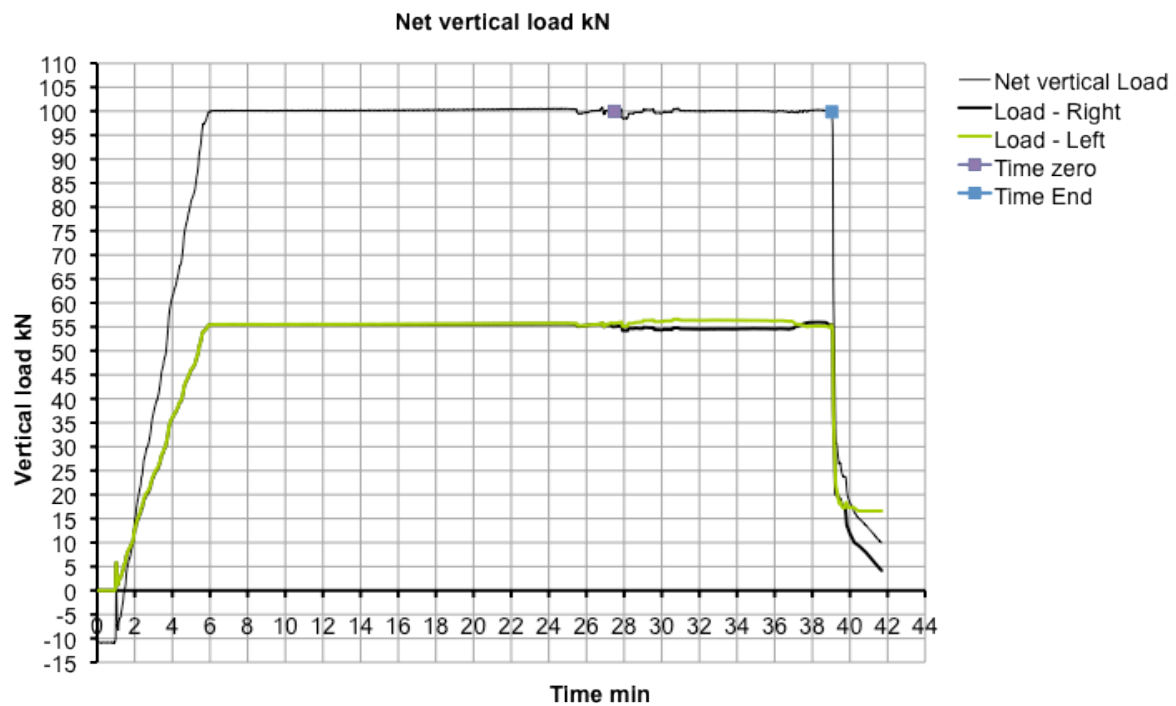
**A4-3. Net vertical loads (left, right and sum minus tare) versus time for the specimen #3; Time zero and Time End also indicates when the fire test occurs.**
