ECSC Research Project RFS-PR-09032

"STRUCTURAL APPLICATIONS OF FERRITIC STAINLESS
STEELS"

Report on field corrosion trials (Deliverable WP7.2)

June, 2013

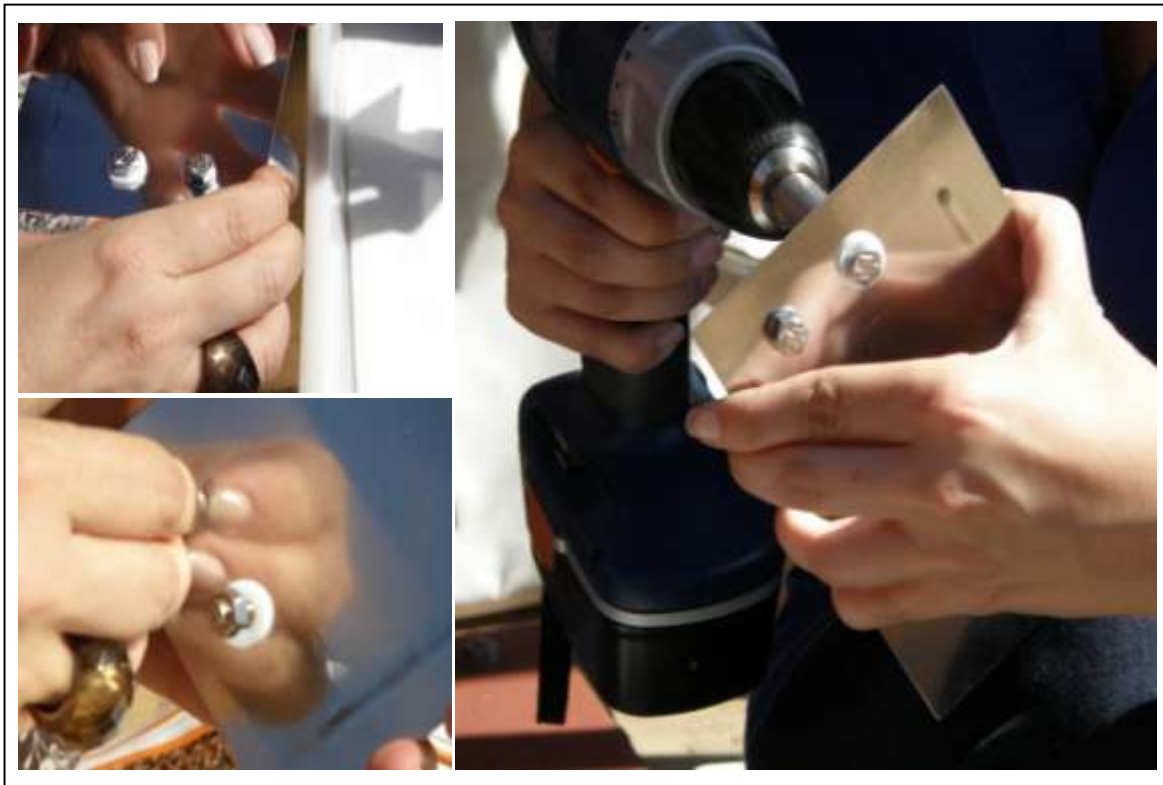
Figure 2. - Drilling of samples before exposure

Afterwards, two holes are carefully drilled into the sample in order to be bolted using plastic and metallic washer. The screwing of the samples is made just before putting on exposure (figure 2).

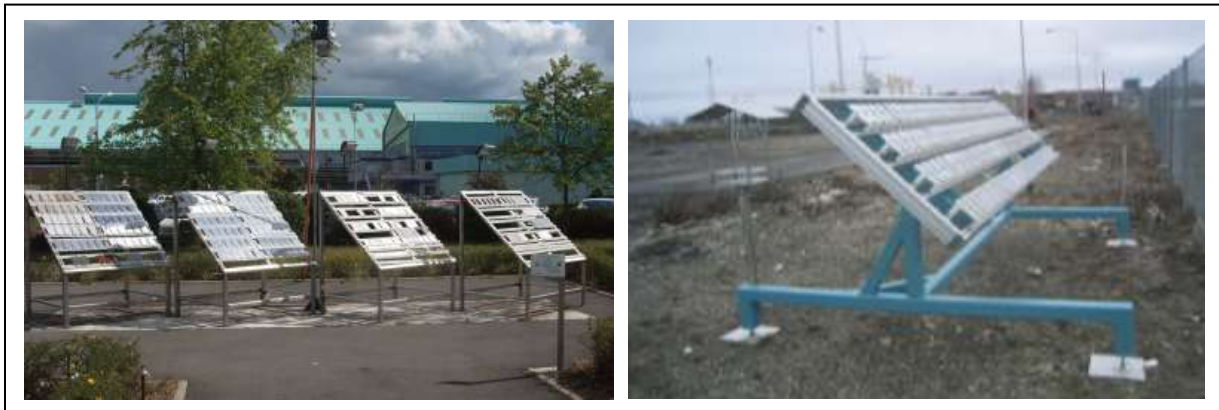
Figure 4. - Exposure racks from Isbergues (left) and Tornio (right)

The device avoids contact between samples so as to corrosion products do not contaminate samples each other. This device lets an easy sample removing at the same time that avoids a fail of them. All test specimens are exposed to the same atmospheric conditions with uniform air access from any direction.

Figures 4 and 5 show the exposure racks placed on Isbergues, Tornio, Seville and Ljubljana.

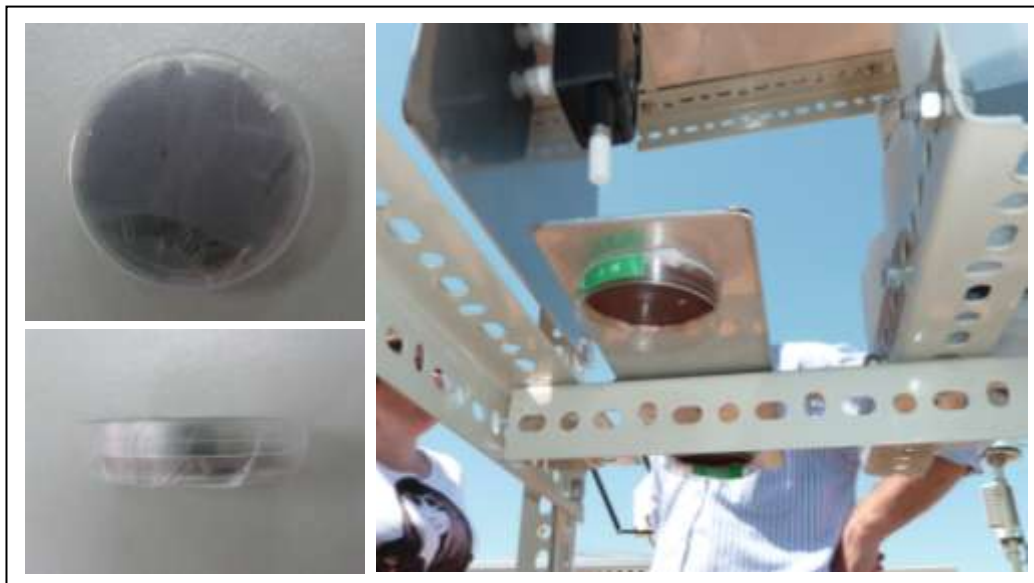
Figure 6. - SO₂ detectors

According to ISO 9225, test of sulphur dioxide on the environment is performed by plates with PbO₂. Acerinox is in charge of making the SO₂ detectors, sending to every test station, and finally analyses the plates after every exposure. Figure 6 shows an example of the plates on exposure.

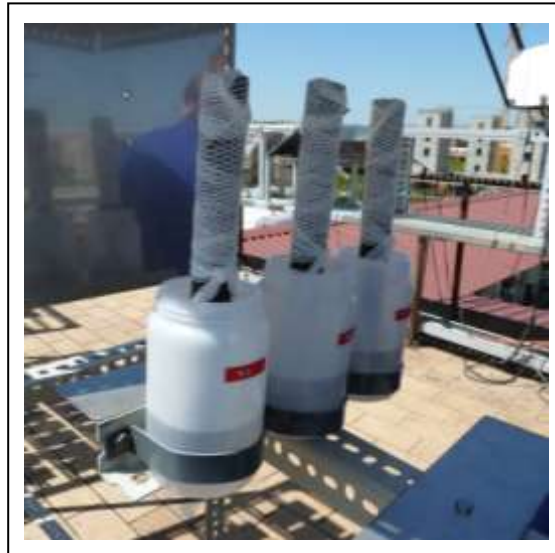
Figure 7. - Cl- detectors

The measurement of airborne salinity, chlorides, is carried out by wet candle method (ISO 9225). The data of airborne salinity are measured in the test station, monthly the detectors are changed by new ones and analysed (figure 7).

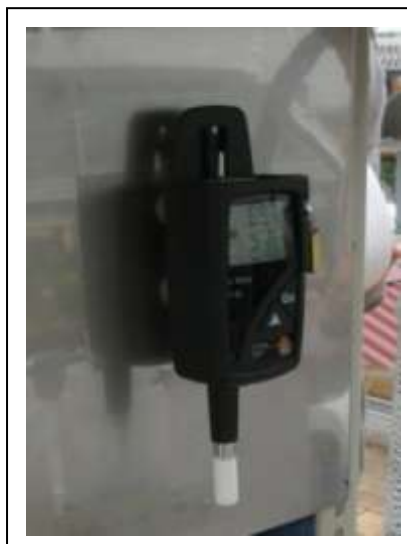
Figure 8. - Data Logger device

The temperature and relative humidity collection is carried out in order to obtain the time of wetness parameter (TOW). This value is defined as the percentage of hours on exposure which relative humidity is higher than 80% and temperature higher than 0°C. The device which registers these values is named Data Logger (figure 8).

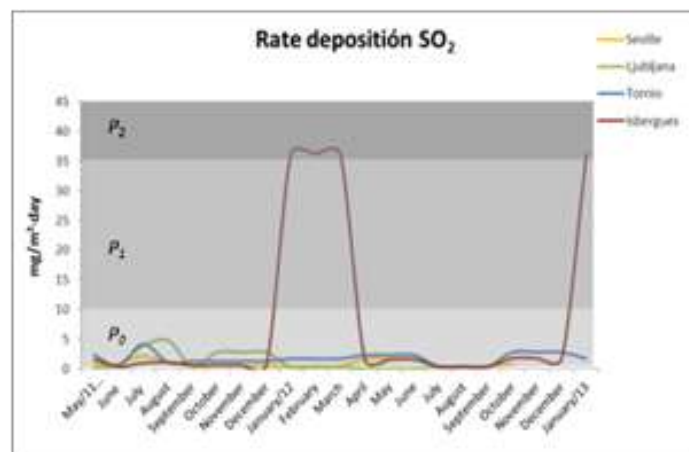
Figure 9. – SO₂ deposition rate comparison

The SO₂ values are very low in all the tested environments. Only Isbergues have suffered and significant increase in a short period of time during the test.

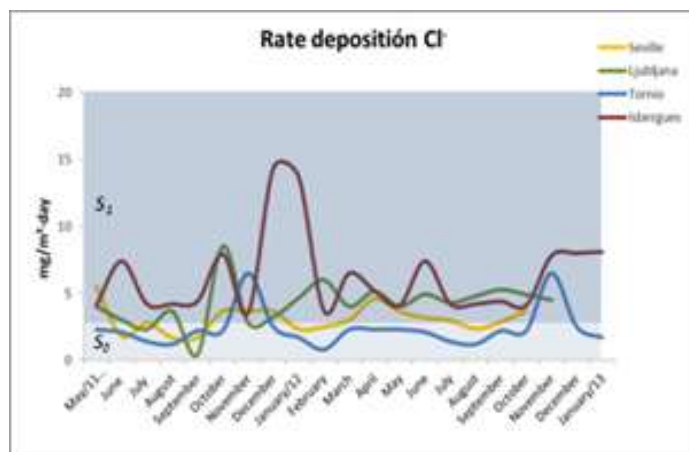
Figure 10. – Chlorides deposition rate comparison

The chloride content is low in all the environments, even though in the marine atmosphere from Tornio.

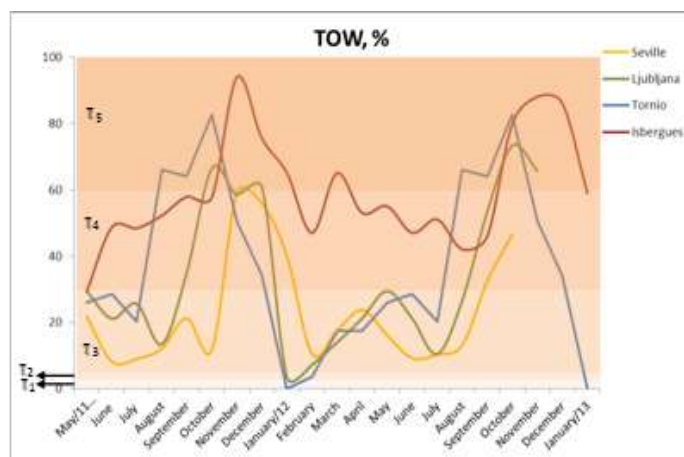
Figure 11. – TOW value comparison

TOW values are higher in Isbergues. The rest of them are very variable, especially the values from Tornio.

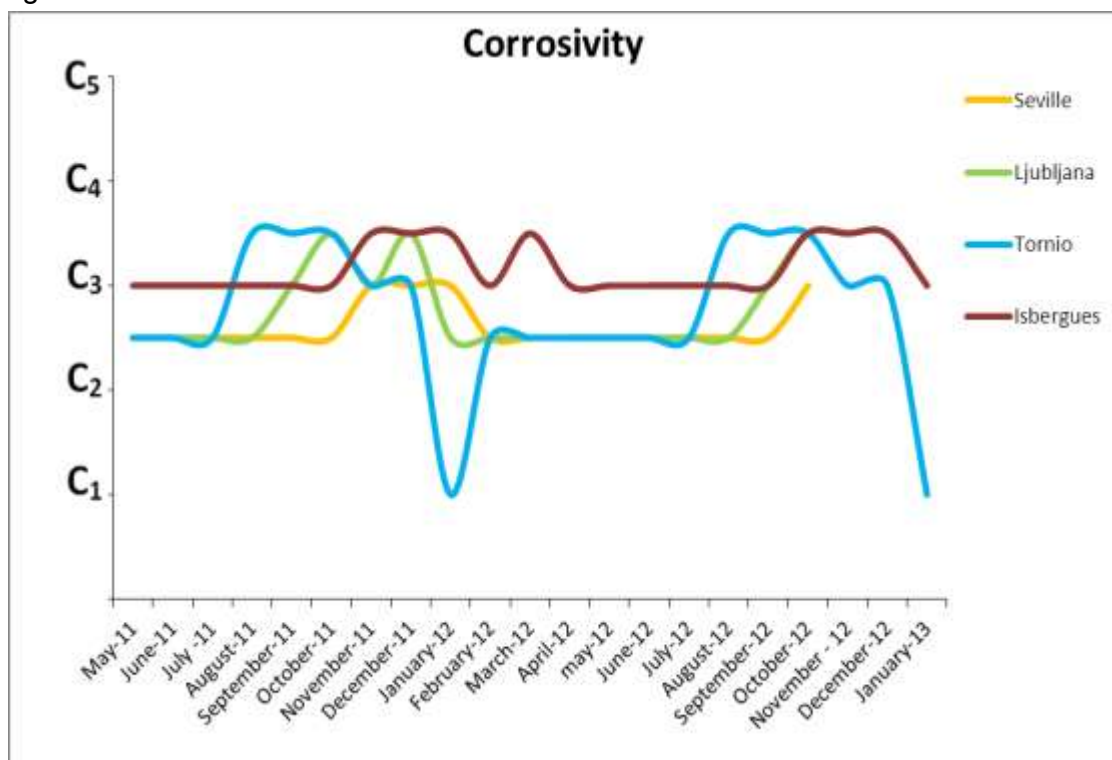
Figure 12. – Corrosivity of test sites

Due to the location and activities performed on the test sites area the atmospheres are classified as follows:

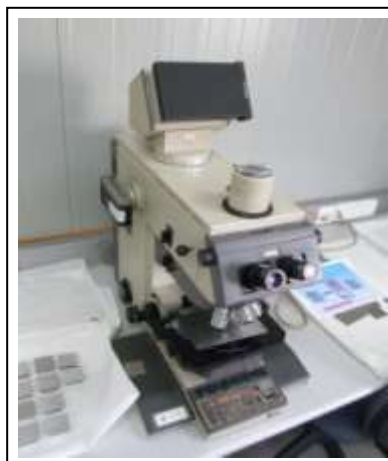
Figure 15. - Microscope

The pits evaluation is based on ASTM-G46 standard. The procedure is carried out by means of a microscope eyepiece. The number of pits, diameter and depth are measured. In figure 15 the microscope, by means pits count is performed in Acerinox corrosion laboratory, is observed.

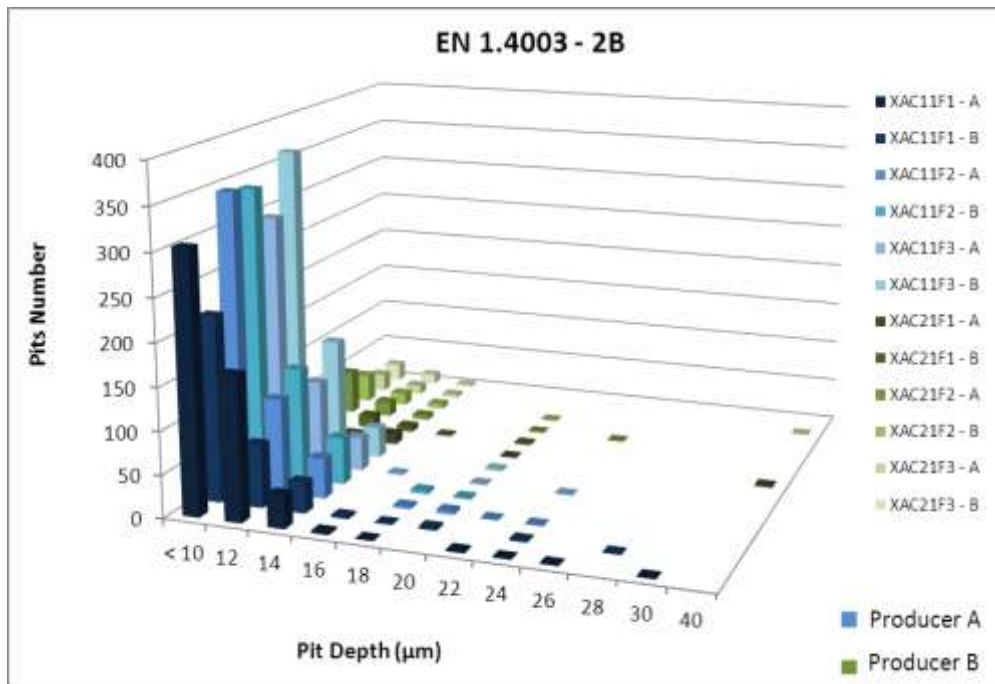
Figure 18. – Number of pits vs pit depth. Seville 1st extraction

Pits count is carried out on EN 1.4003-2B flat samples. Figure 18 and 19 show number of pits represented as a function of pit depth and pit diameter.

It has been necessary an exhaustive and laborious observation of the samples due to the high number of pits and the small size of most of them. It can be observed the clear difference in the number of pits from the different producers, samples from producer A have a higher number of them. In both cases, most of pits have a depth lower than 10 microns and a diameter lower than 50 microns.

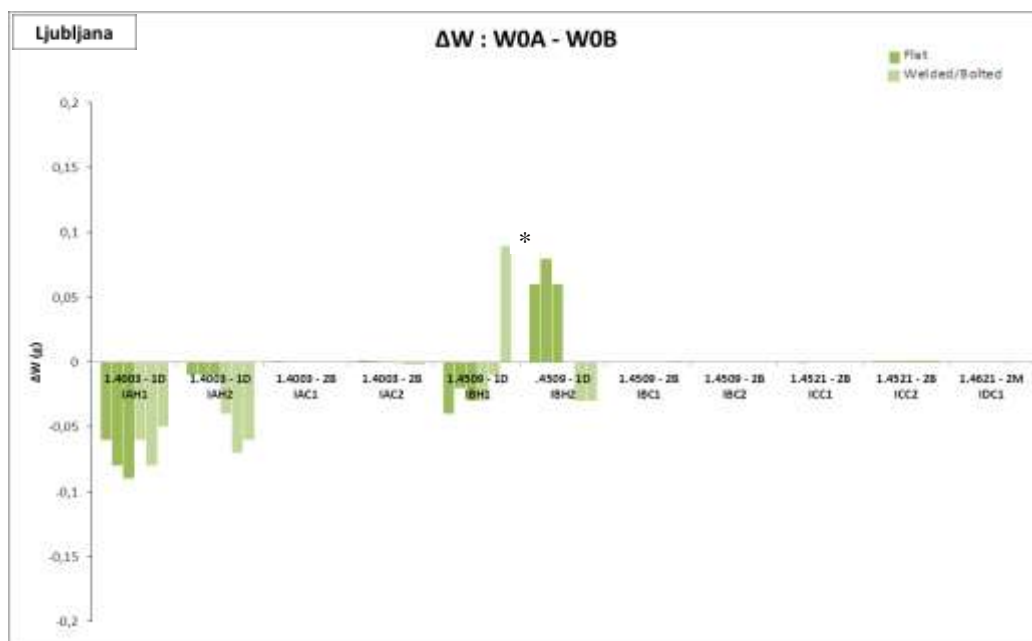
Figure 21. – Mass variation during Ljubljana test (12 months)

Figure 21 shows mass variation of samples after test without any cleaning procedure.

The values with an indication on the graph (*) can be wrong due to a mistake in sample weight measurement.

EN 1.4003 samples are the most stained ones with a significant mass variation. The mass loss of this material, after cleaning procedure carried out in Ljubljana, is shown in figure 22. The cleaning process in Ljubljana consisted in a mechanical cleaning of samples surface.

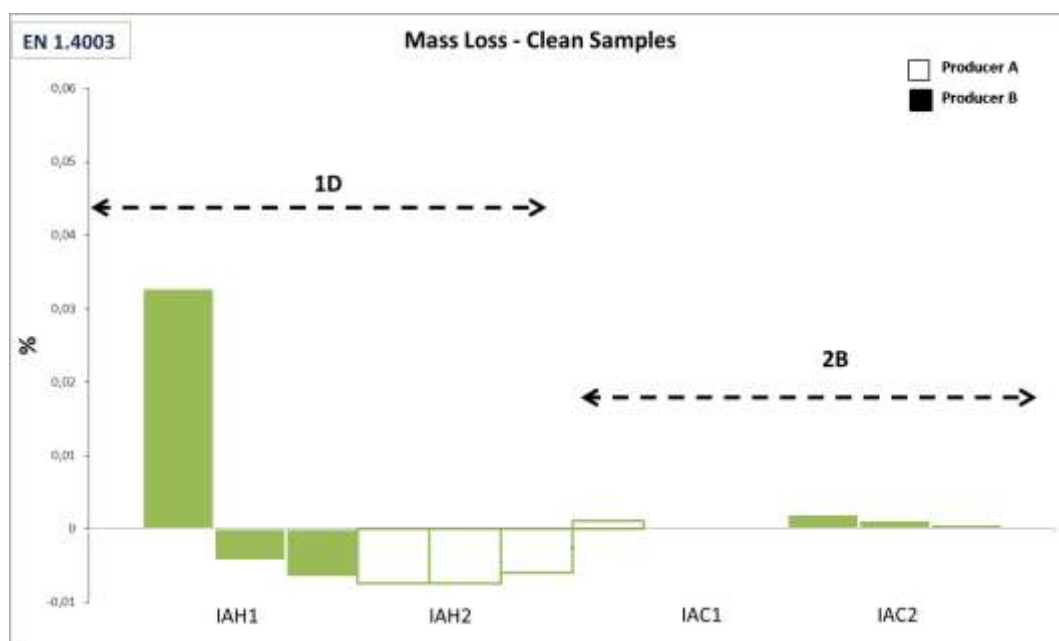
Figure 22. – Percentage of mass loss after rusty products removing

It can be noticed the anomalous behaviour of mass variation after cleaning process.

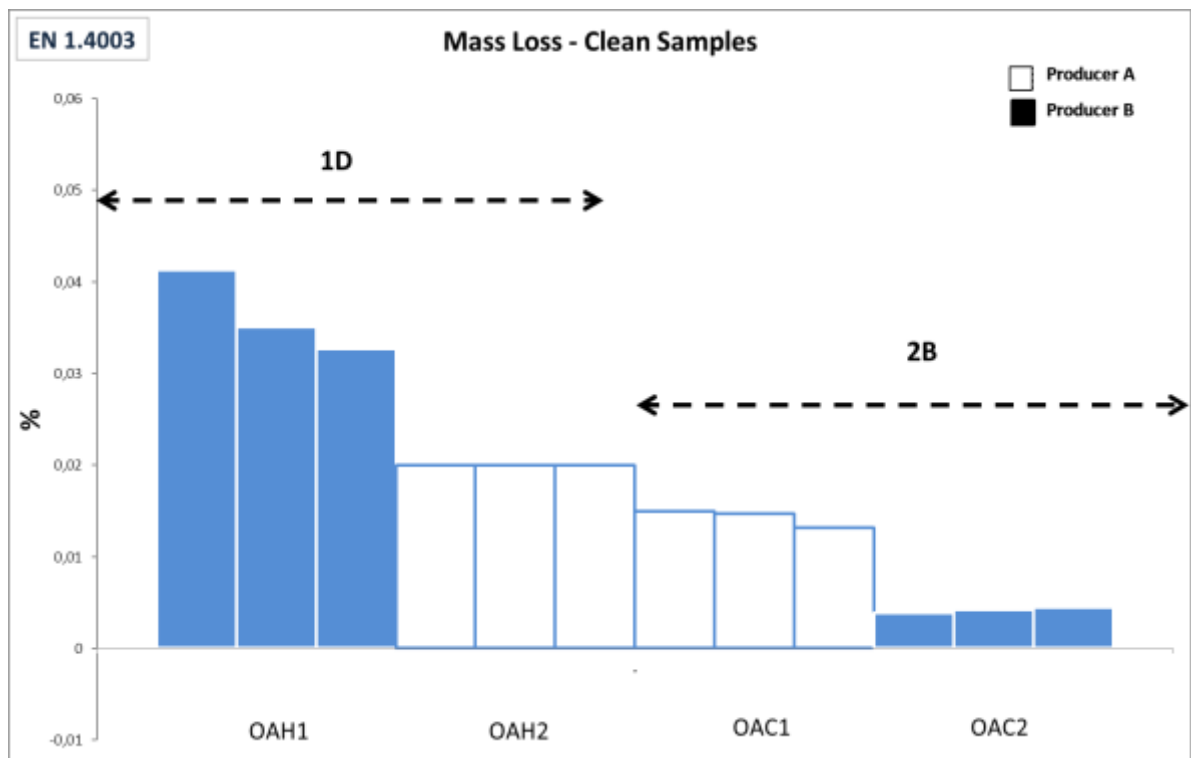
Figure 25. – Percentage of mass loss after rusty products removing

Samples from Tornio were cleaned by means of a mechanical process and a chemical cleaning. The solution used is HCl (18 % w/w) and Hexamethylene Tetramine (0,35 % w/w), where samples were introduced 1 to 2 minutes.

After cleaning, EN 1.4509 mass variation is nearly 0. Only EN 1.4003 samples suffered a significant mass variation which can be observed in figure 25.

It is observed the highest percentage of mass loss in 1D specimens.

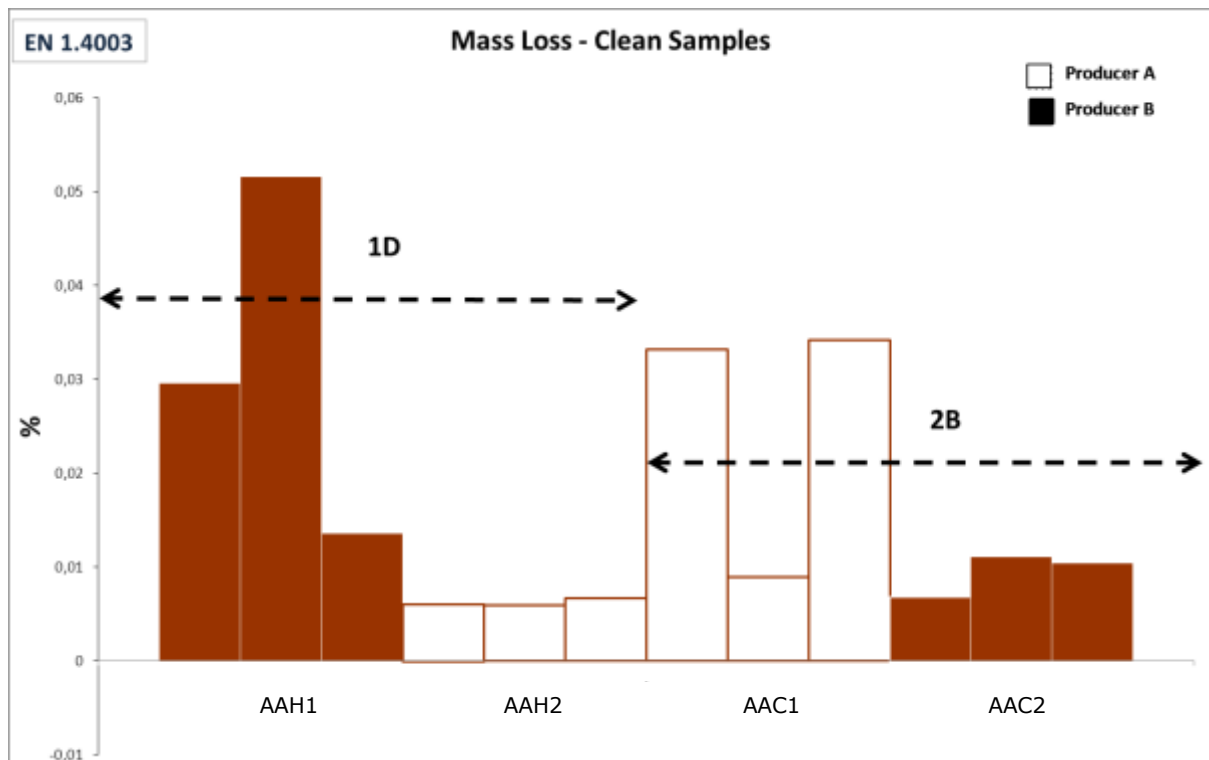
Figure 27. – Percentage of mass loss after rusty products removing

Samples from Isbergues have been cleaned by means of immersion in HCl > 37% + NORUST CM150 HCl (inhibitor) at 55°C to 30" to 3' depending on the corrosion product density.

Mass variation from EN 1.4003 specimens are shown in figure 27.

The highest percentage of mass loss in 1D specimens from producer B (AAH1) and 2B from producer A (AAC1) is observed, which is in concordance with stains on surface.

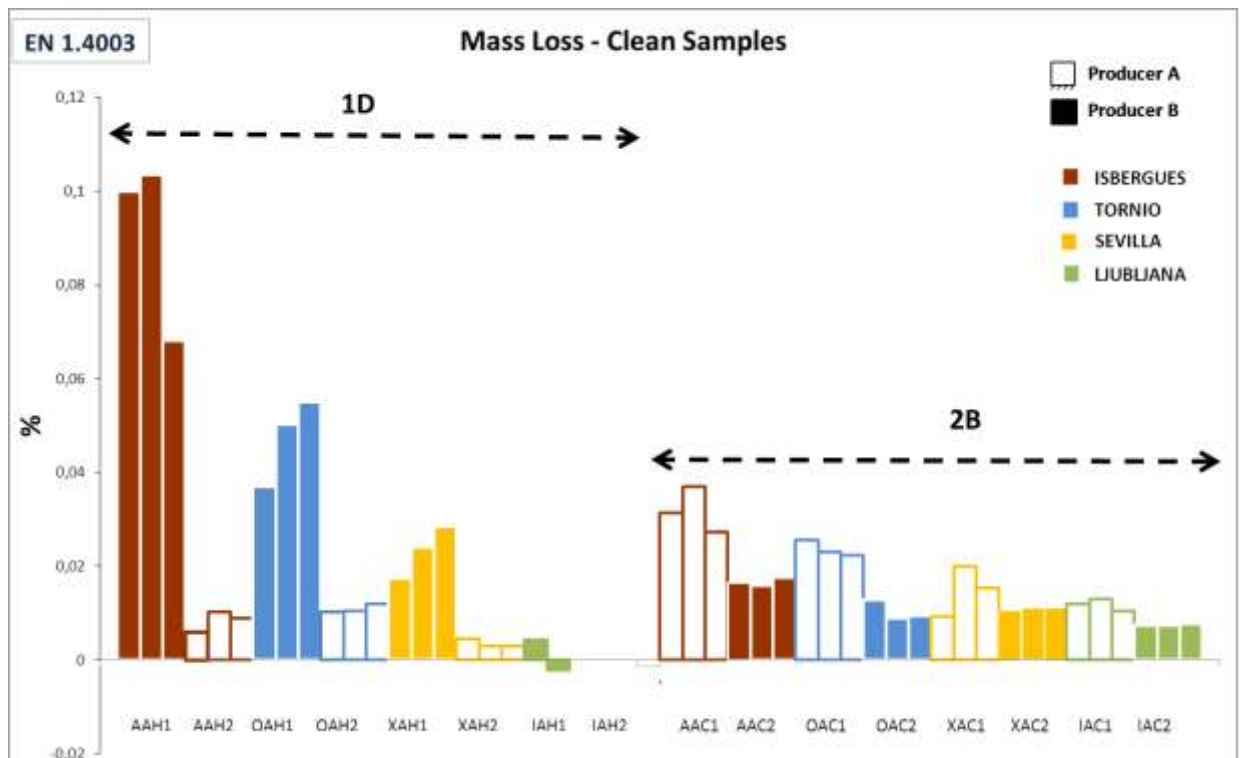
Figure 33.- Mass loss after cleaning process

Figure 33 shows percentage of mass loss after removing rusty products.

It can be noticed the highest mass loss from 1D specimen. The samples from Isbergues have suffered the highest mass loss in both, 1D and 2B specimens, which is in concordance to their higher quantity of stains. In both finishes and producers the tendency from higher to lower mass loss is noticed as following:

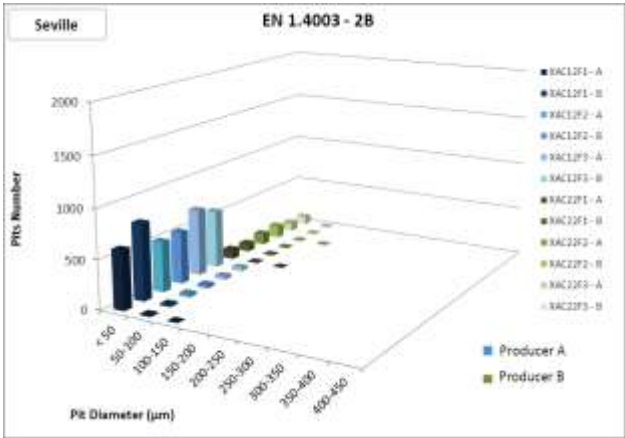
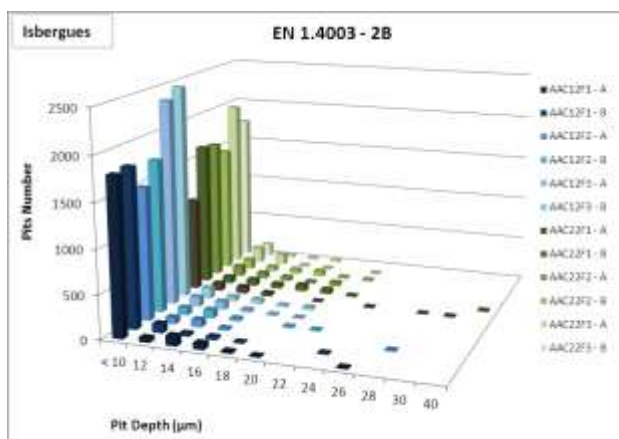
From every test site is shown the number of pits as a function of pits depth and pits diameter (figures 34 to 41).

All the samples show a huge number of pits with depth lower than 10 microns and diameter lower than 50 microns. The lower size and huge number of pits obtained shows the laboriousness of the task of counting pits.

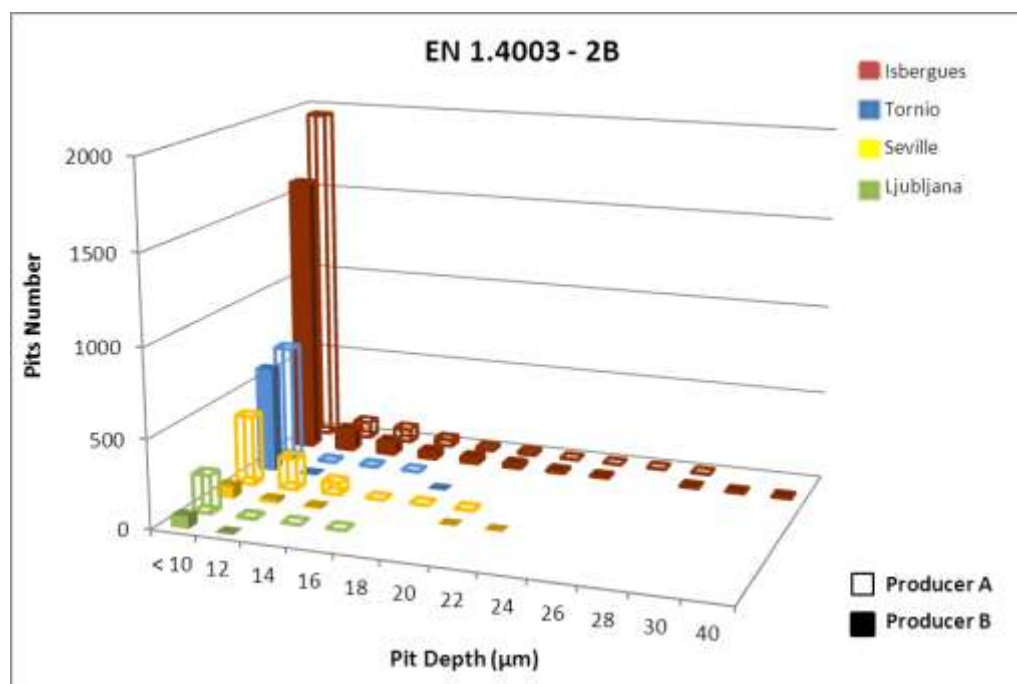
Figure 42.- Comparison of pits number vs. pit depth from test sites

In order to compare the four field exposition places the media values obtained for all the samples are shown in figures 42 and 43.

It can be noticed the higher number of pits from Isbergues (industrial) and the lower one from Ljubljana (rural). The fact that most of pits have depth lower than 10 microns and diameter lower than 50 microns leads to think that these materials have tendency to suffer uniform corrosion in all the exposed environments.

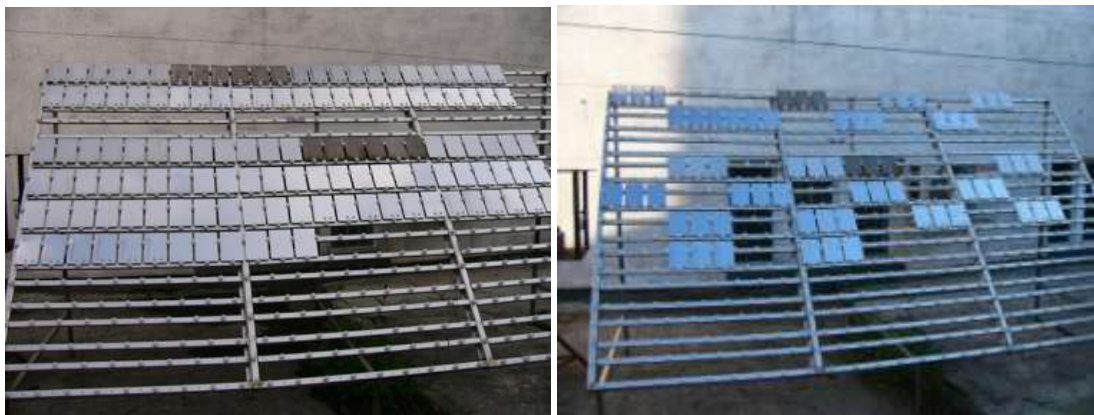
Figure 3: Corrosion stand IMT, exposition 1 (left) from 09.05.2011 to 09.05.2012 and the remaining samples, exposition 2 (right) from 09.05.2011 to 29.11.2012.

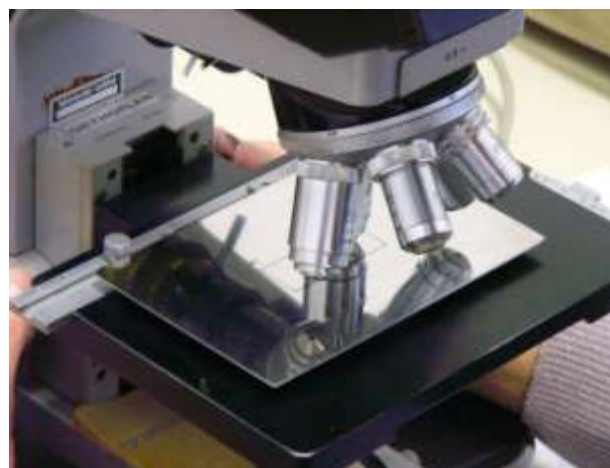
Figure 5: Counting of pits with light microscope.
